# Arizona US 93 NB Silicone Joint Sealant Evaluation (040160)

IGGA/ACPA  
Larry Scofield, P.E.  
6/2/2022

## **Introduction**

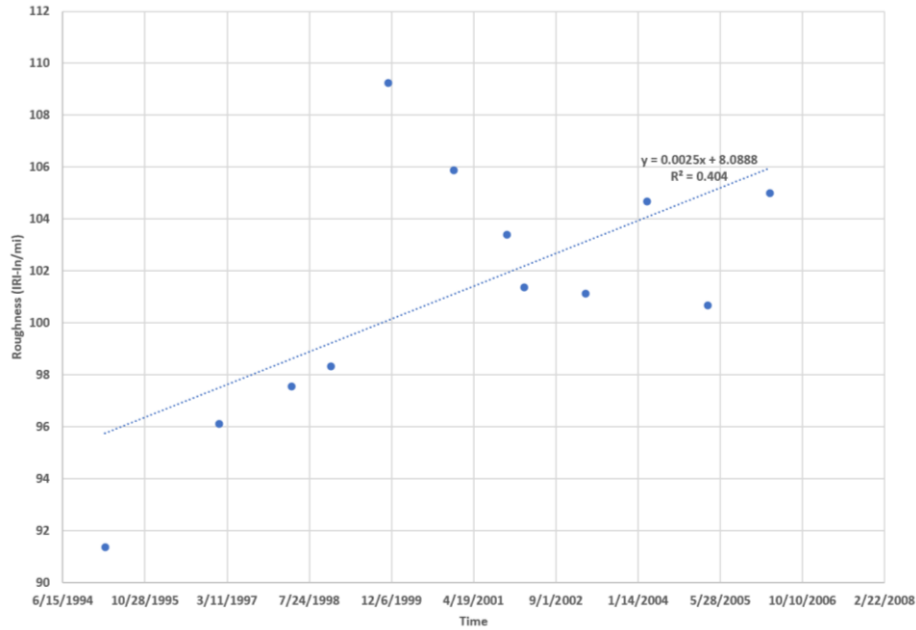
Figure 1 LTPP 040160 Roughness Over Time

As indicated in Figure 1, the roughness (IRI-in/mi) increased approximately 11 inches per mile over time (i.e., one inch per year). However, the data scatter suggests that diurnal curl was occurring as indicated by the abnormally high readings in 1999 and 2001. Since LTPP only collected single time of day measurements, and the time of day was a function of the schedule, this may be the reason for the data scatter.

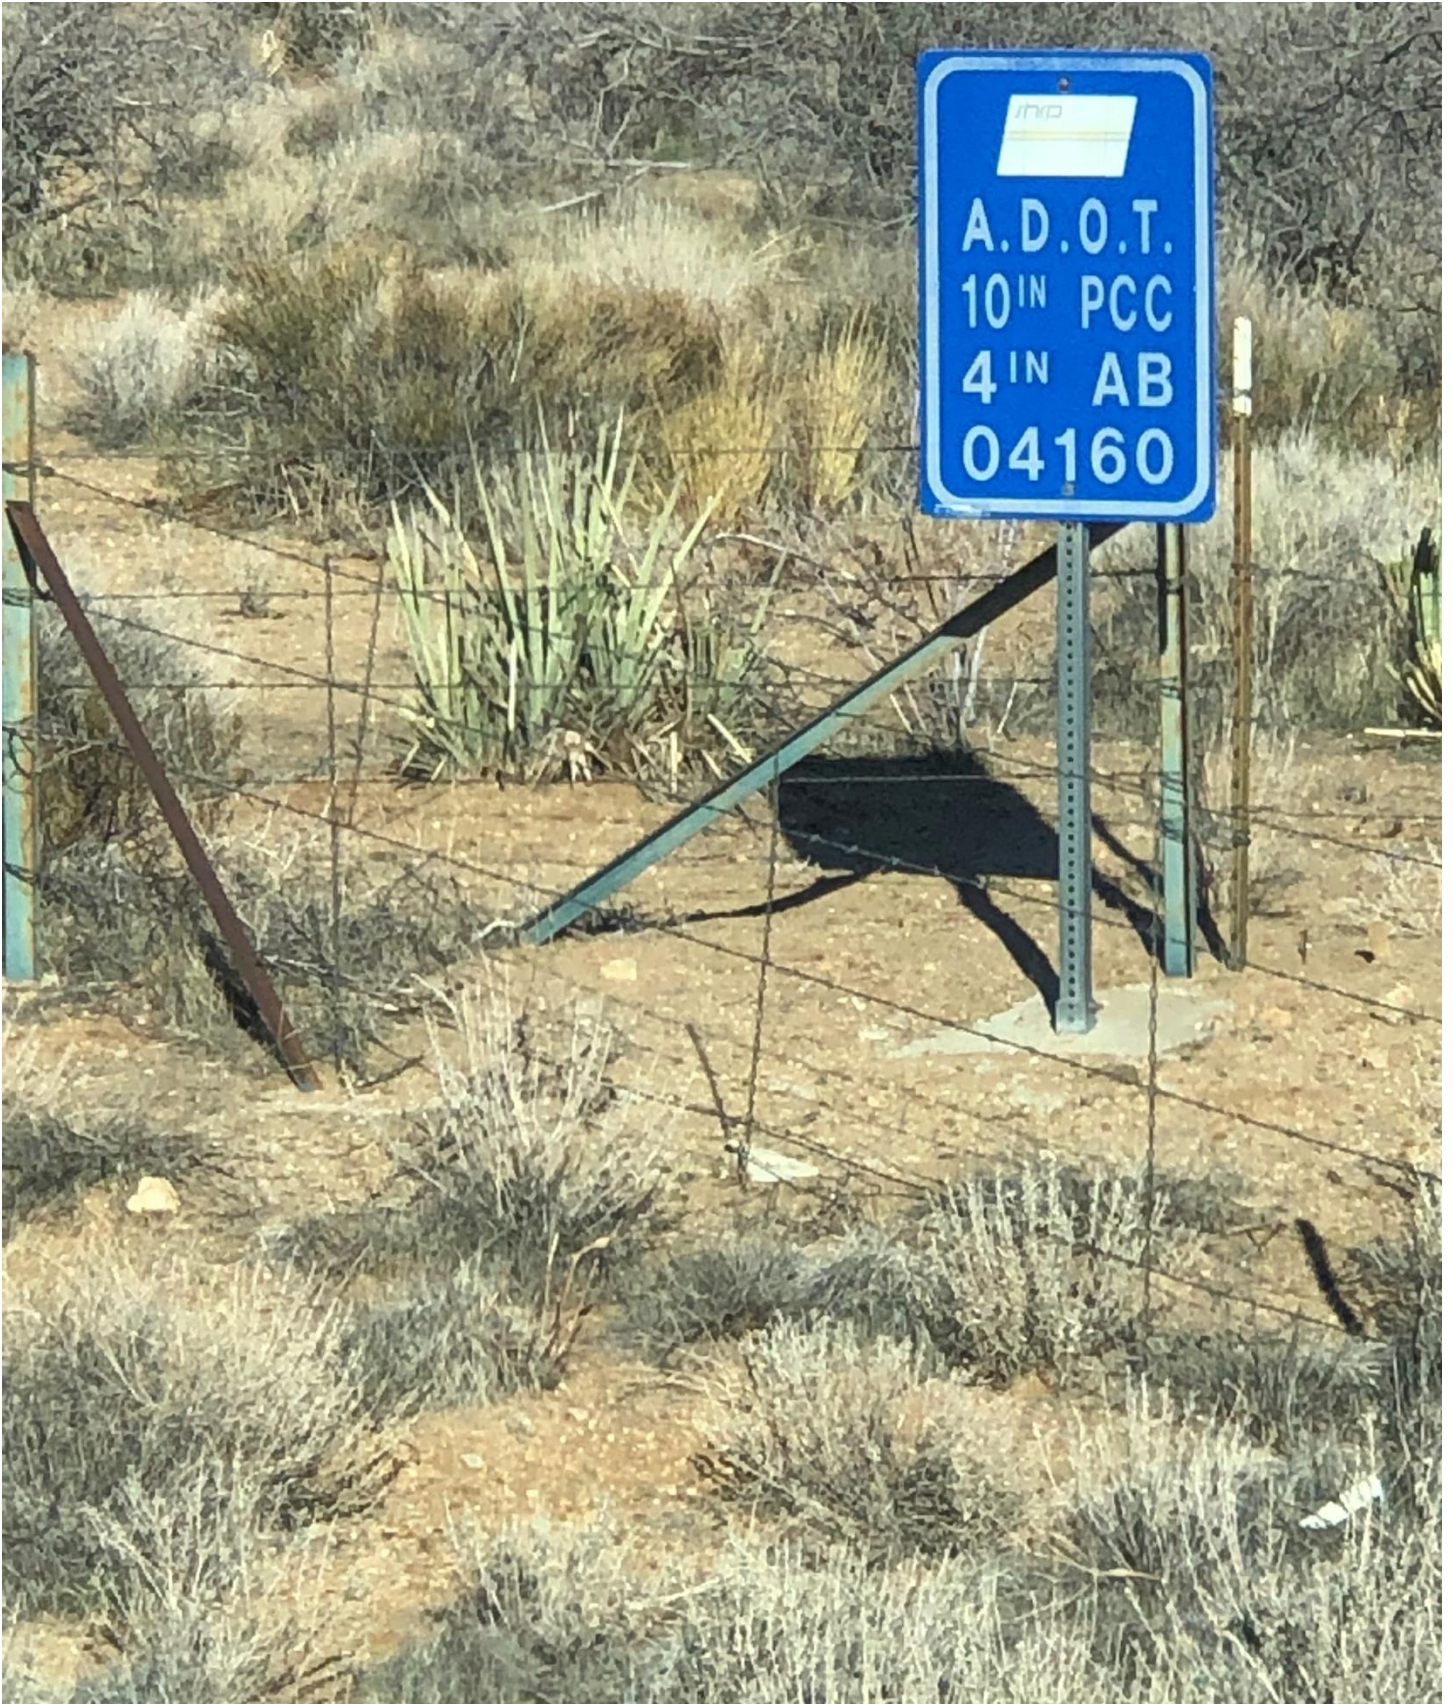
Figure 1-4 (Note the Sign Test Section Number Should be 040160)

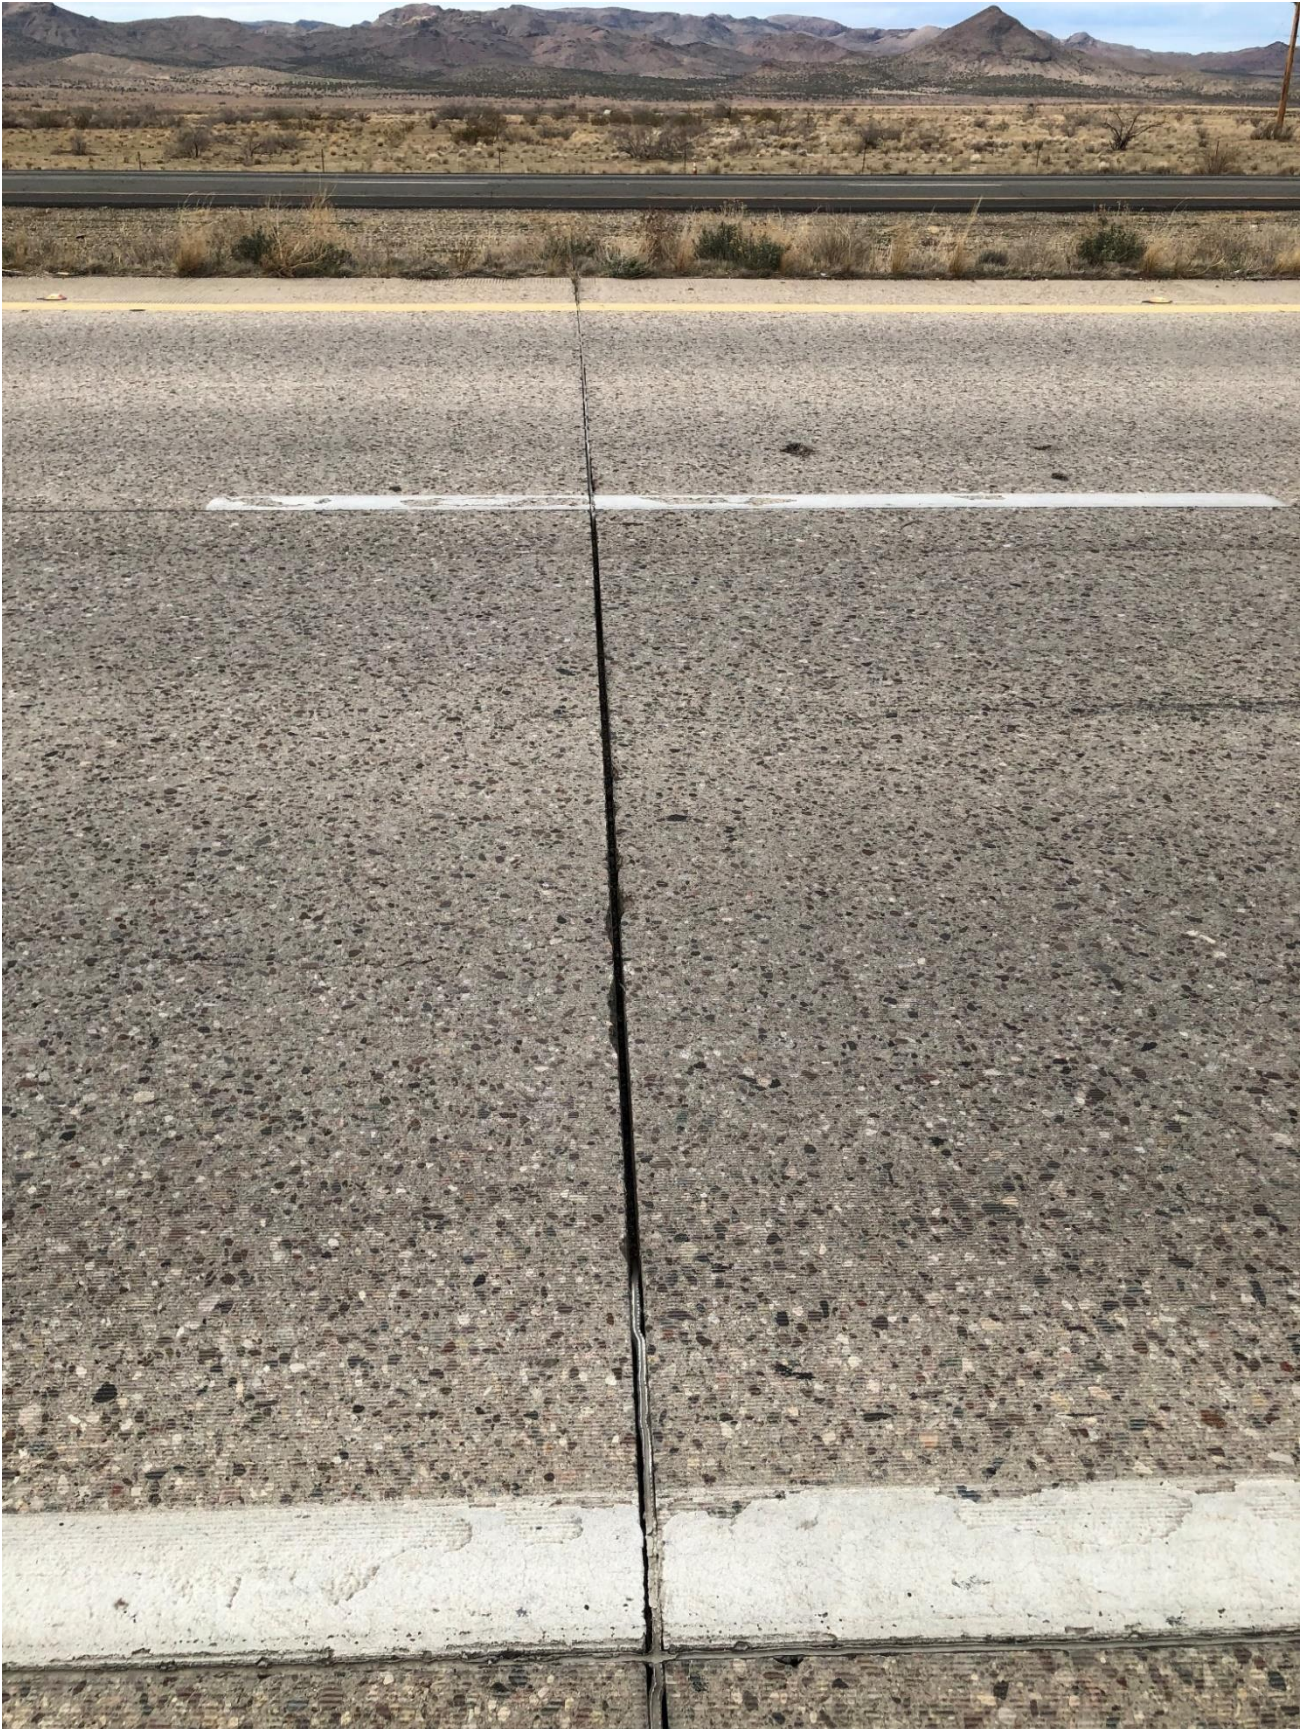
Figure 1-19 (Joint 18)

The criteria of missing sealant can be somewhat misleading as in many cases the sealant still exists in the joint, but the concrete has deteriorated away from the silicone and is no longer in contact. As such, the sealant cannot function as intended in terms of preventing water and incompressible ingress. Hopefully, a future effort will attempt to verify whether the concrete has joint associated distress. As indicated in Table 1, most of the silicone sealant still exists in the joint after 29 years. Joint 18, observed on January 18<sup>th</sup>, appeared wider than the other joints. Further investigation is needed to determine why this joint performed differently or whether it was a construction joint.

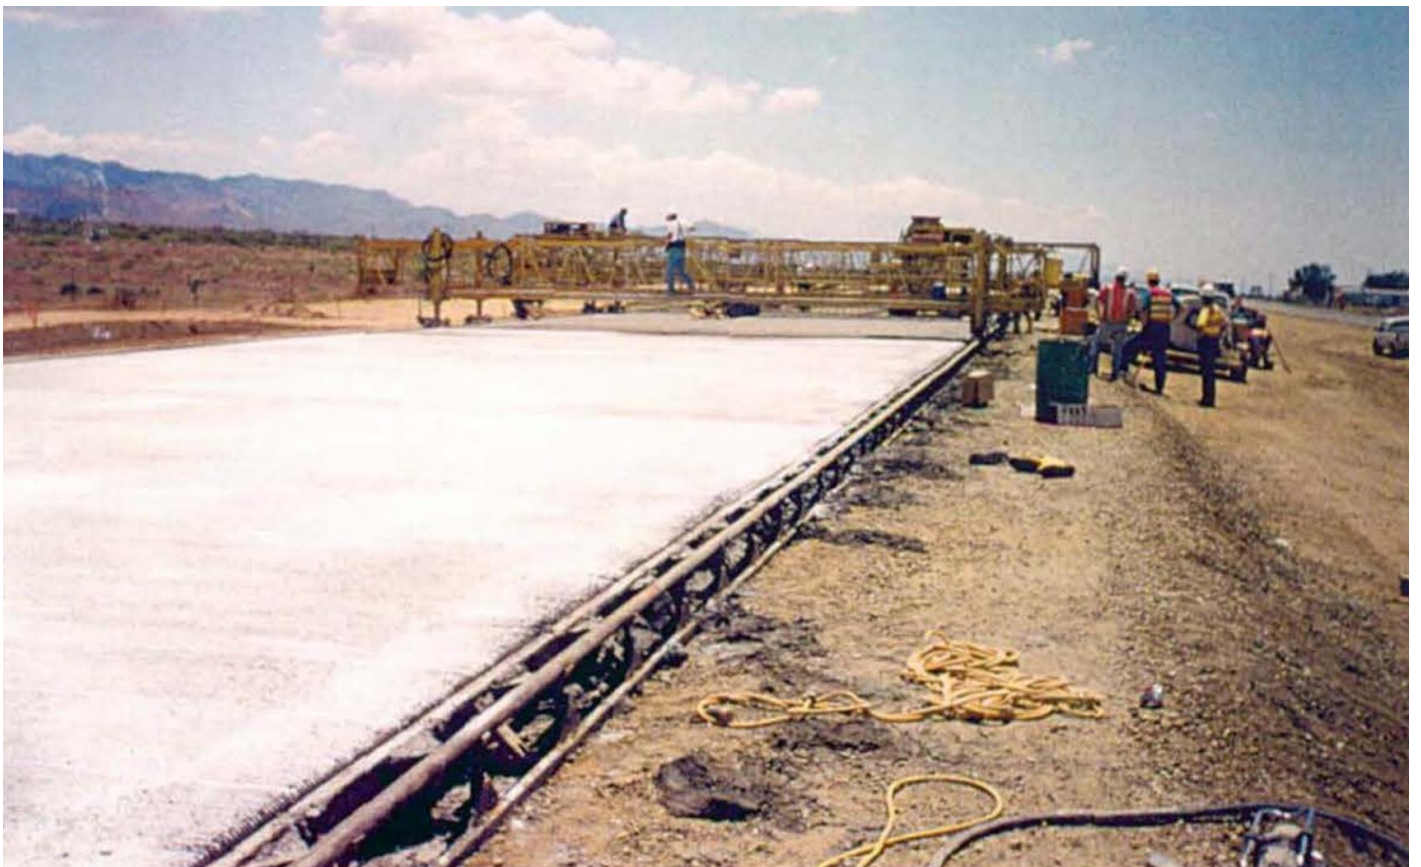
Excerpts from the LTPP Construction report are provided in Appendix 5. That report indicates the test section was paved using a Bidwell and ready-mix concrete. The slump ranged widely during construction (2.5" to 6") and curing compound was applied by hand and appeared inadequate. From the report, it appears consolidation of the mix was also an issue. One construction joint was noted.

**Figure 3-4 Photo of Inadequate Coverage of Hand Sprayed Curing Compound**
