2021

SR59 2021 Sealant Test Section Evaluation Report

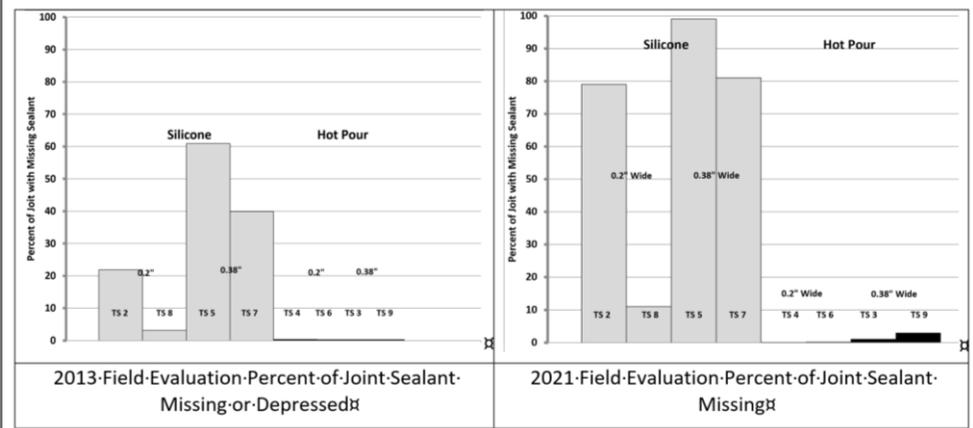
The hot pour sealants performed significantly better in the 2013 and 2021 evaluations than the silicone. Similarly, the narrow joint design significantly outperformed the more traditional wider joint design

It appears the narrow joint design protects better against vertical loading on the sealant during inclement weather or winter maintenance operations.

TABLE-1-Percent-of-Joint-Sealant-Missing-from-Transverse-Joint¶

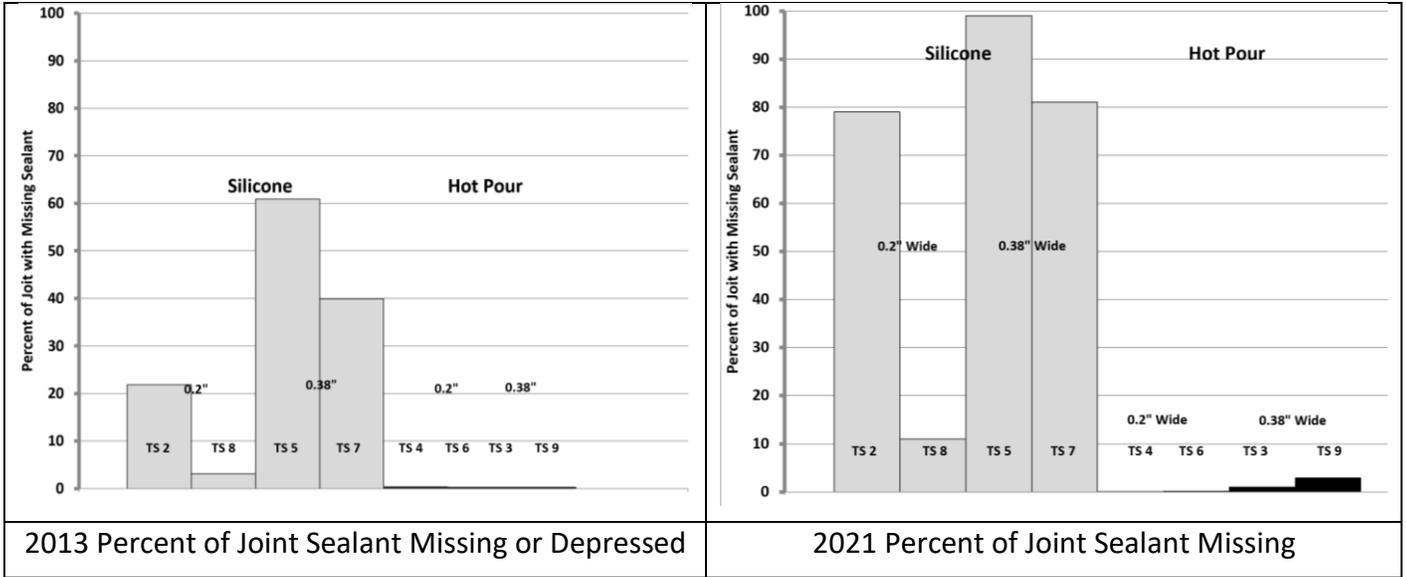
A visual assessment of the transverse joints was conducted in 2013 and 2021 for missing or depressed sealant. The visual joint sealant results are indicated in Figure 2. The columns in Figure 2 indicate the percent of sealing that is missing from the transverse joints in the outside lane of each test section with sealant installed. As indicated, the hot pour sealants performed significantly better in the 2013 and 2021 evaluations than the silicone. Similarly, the narrow joint design significantly outperformed the more traditional wider joint design. This is somewhat ironic since the narrow joint used had a significantly worse shape factor. With that said, the question arises whether the narrow joint width protects better against vertical loading on the sealant during inclement weather or winter maintenance operations. The original shape factor research did not consider vertical loading on the sealant⁵.

Figure 2 Percent of Joint Sealant Missing from Transverse Joint

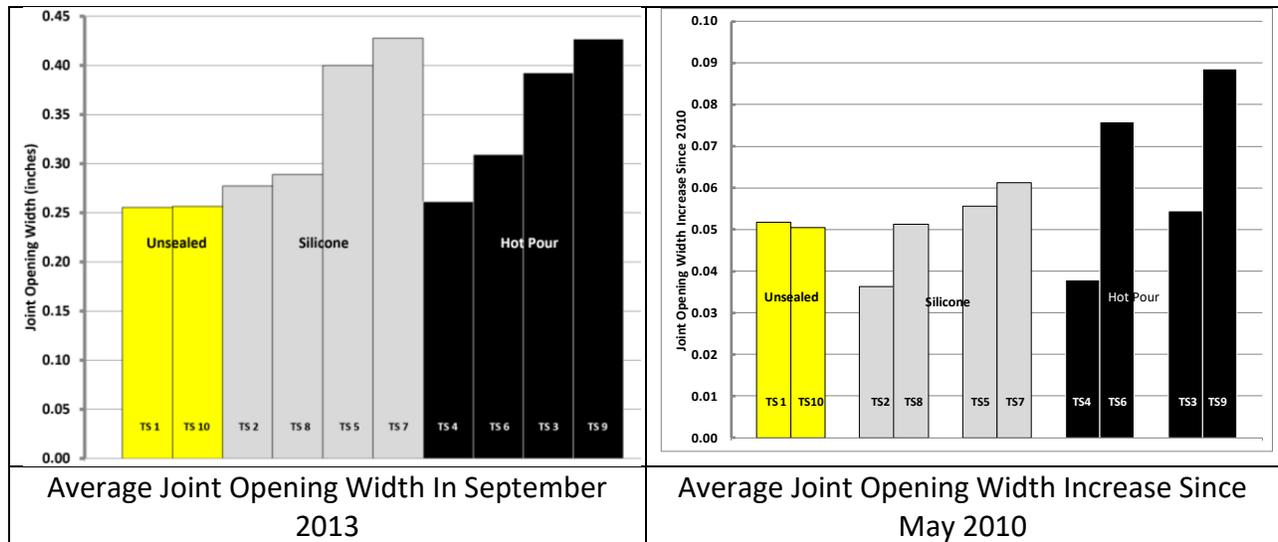
The left-hand side of Figure 3 indicates the average joint opening width for each test section in 2013. As indicated, the unsealed sections have the most consistent results as would be expected. The difference between the replicates for the other sealed configuration, particularly the hot pour, are impacted by the ability to correctly measure the width due to the presence of the sealant.

The right-hand side of Figure 3 indicates joint opening width increases between May 2010 and September 2013. The increase ranged from approximately 0.04 to 0.09 inches. On May 23, 2010, the temperature ranged from 75 to 90 degrees and on Sept 25 & 26, 2013 it ranged between 53 and 75 degrees during joint opening measurements.

Figure 3 September 2013 Joint Opening Width and Increase in Width Since May 2010

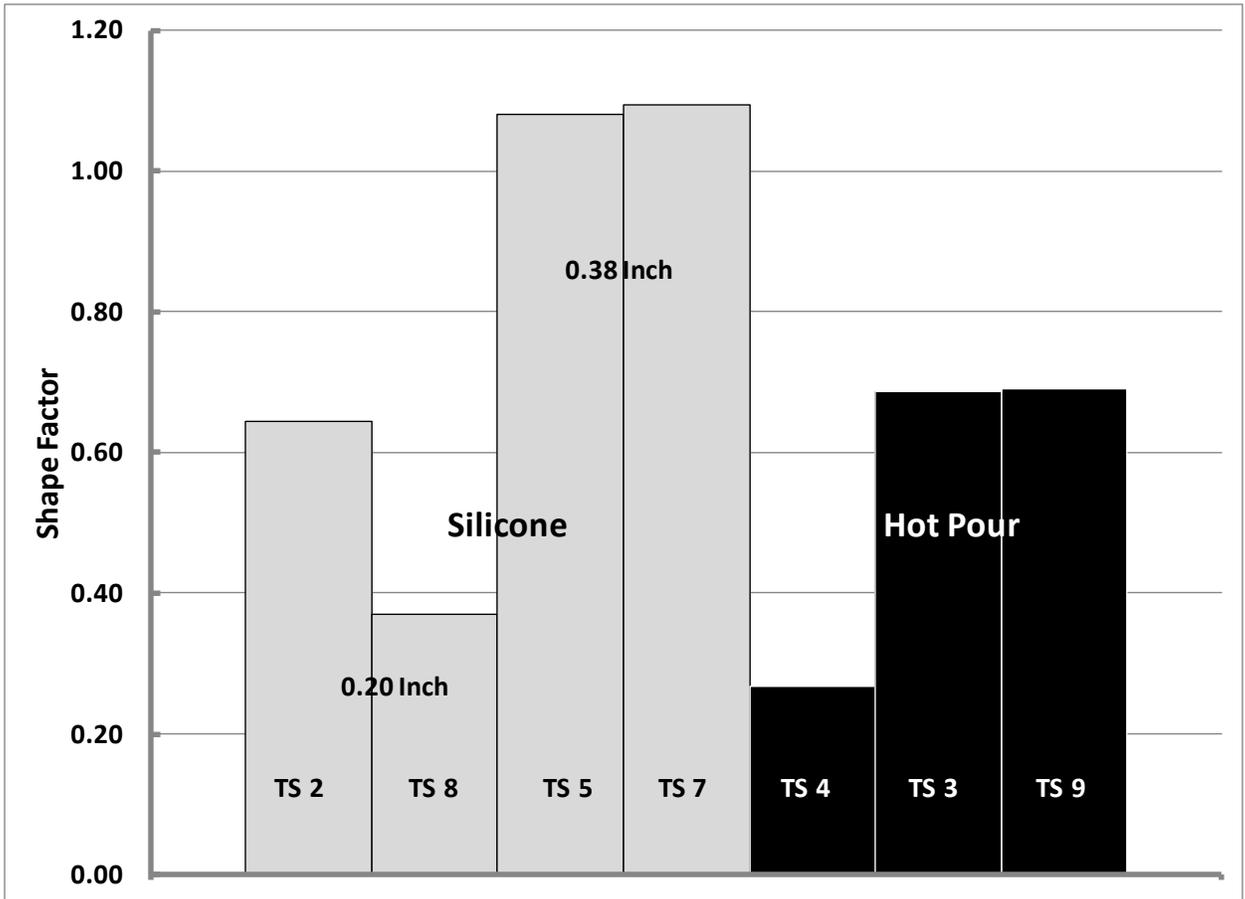
In 2013, samples were extracted from selected joints to assess the shape factor of each of the different sealant/installation combinations. However, the shape factor for the narrow hot pour installation should only be considered a rough approximation of the actual shape factor. The bond of this sealant was still very good and sample extraction proved difficult and the extracted sample was always damaged and distorted to some degree. The actual shape factor is presumed to be somewhat better than what was measured.

Figure 3 Shape Factor for Extracted Samples for Test Sections

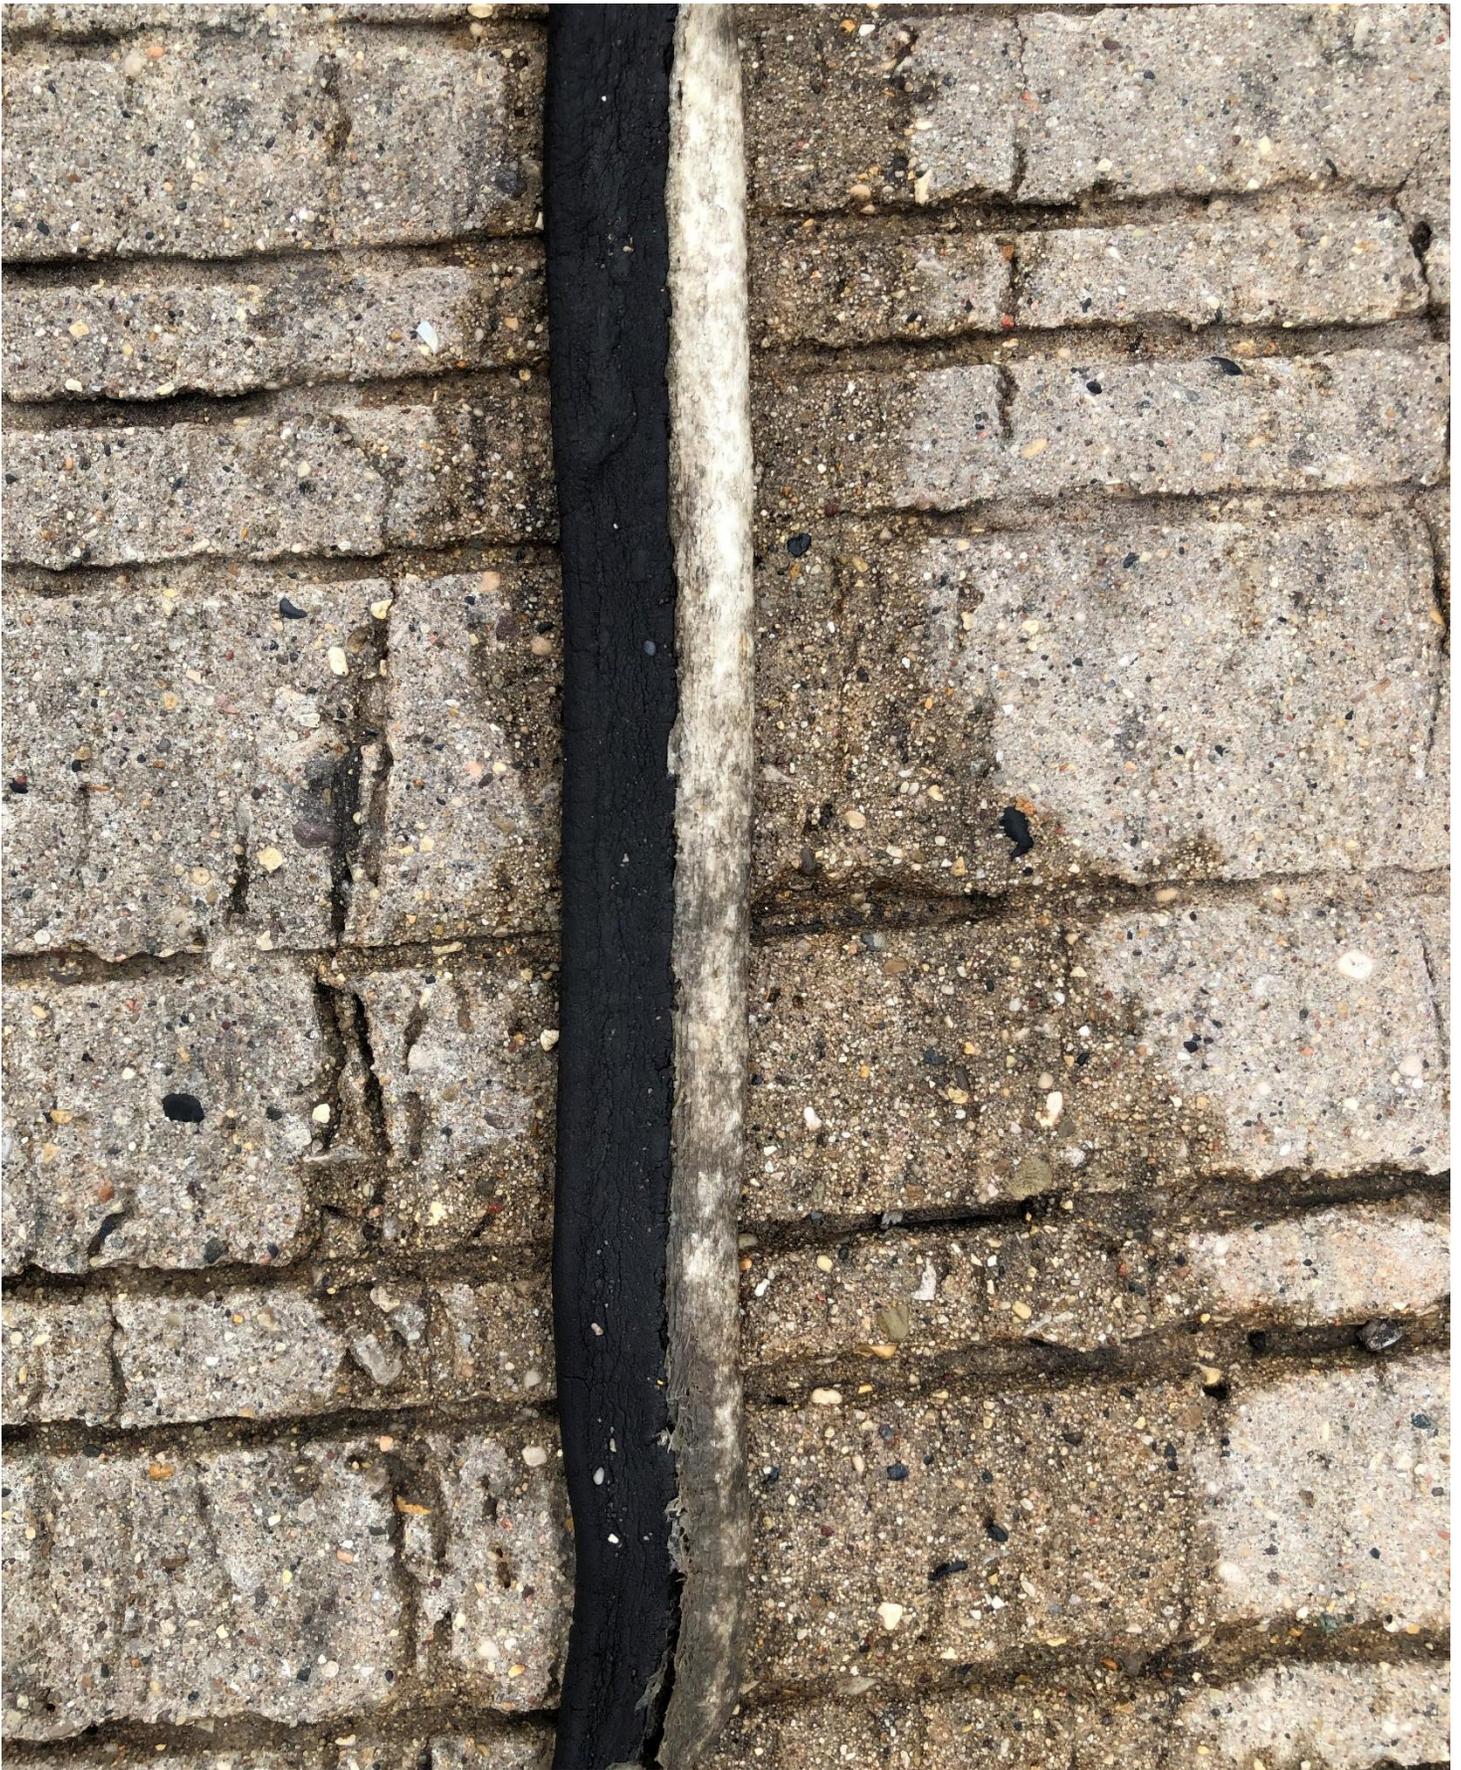
Figure 1-2 Backer Rod Floating Out from Bottom

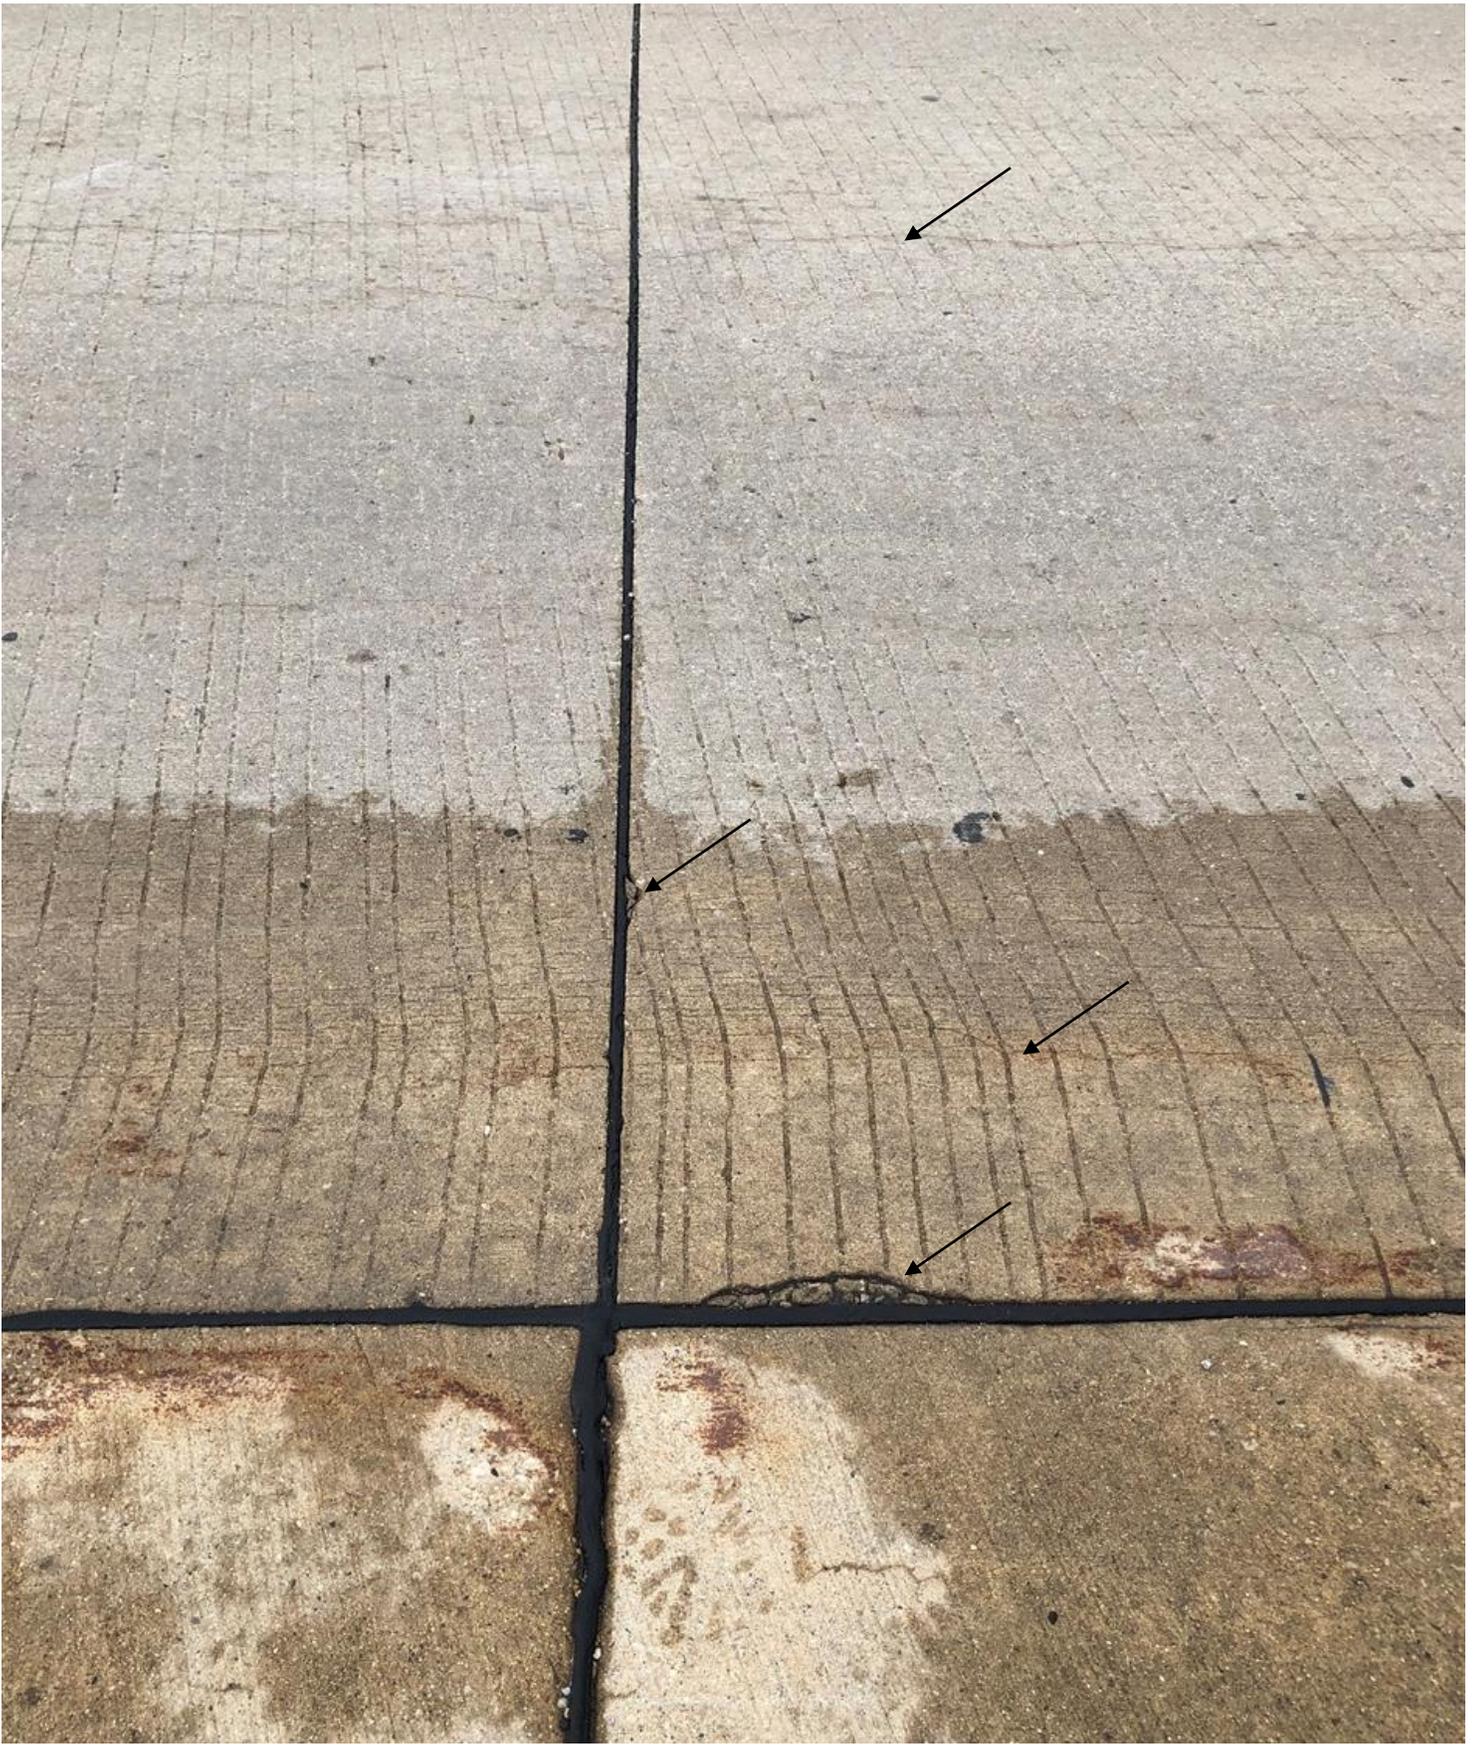
Figure 1-3 Crack in Pavement, Spall at Curb, Spall in Transverse Joint where Tining Crosses, Note also cohesive failure in hot pour- This sealant would have been rated as 0% missing

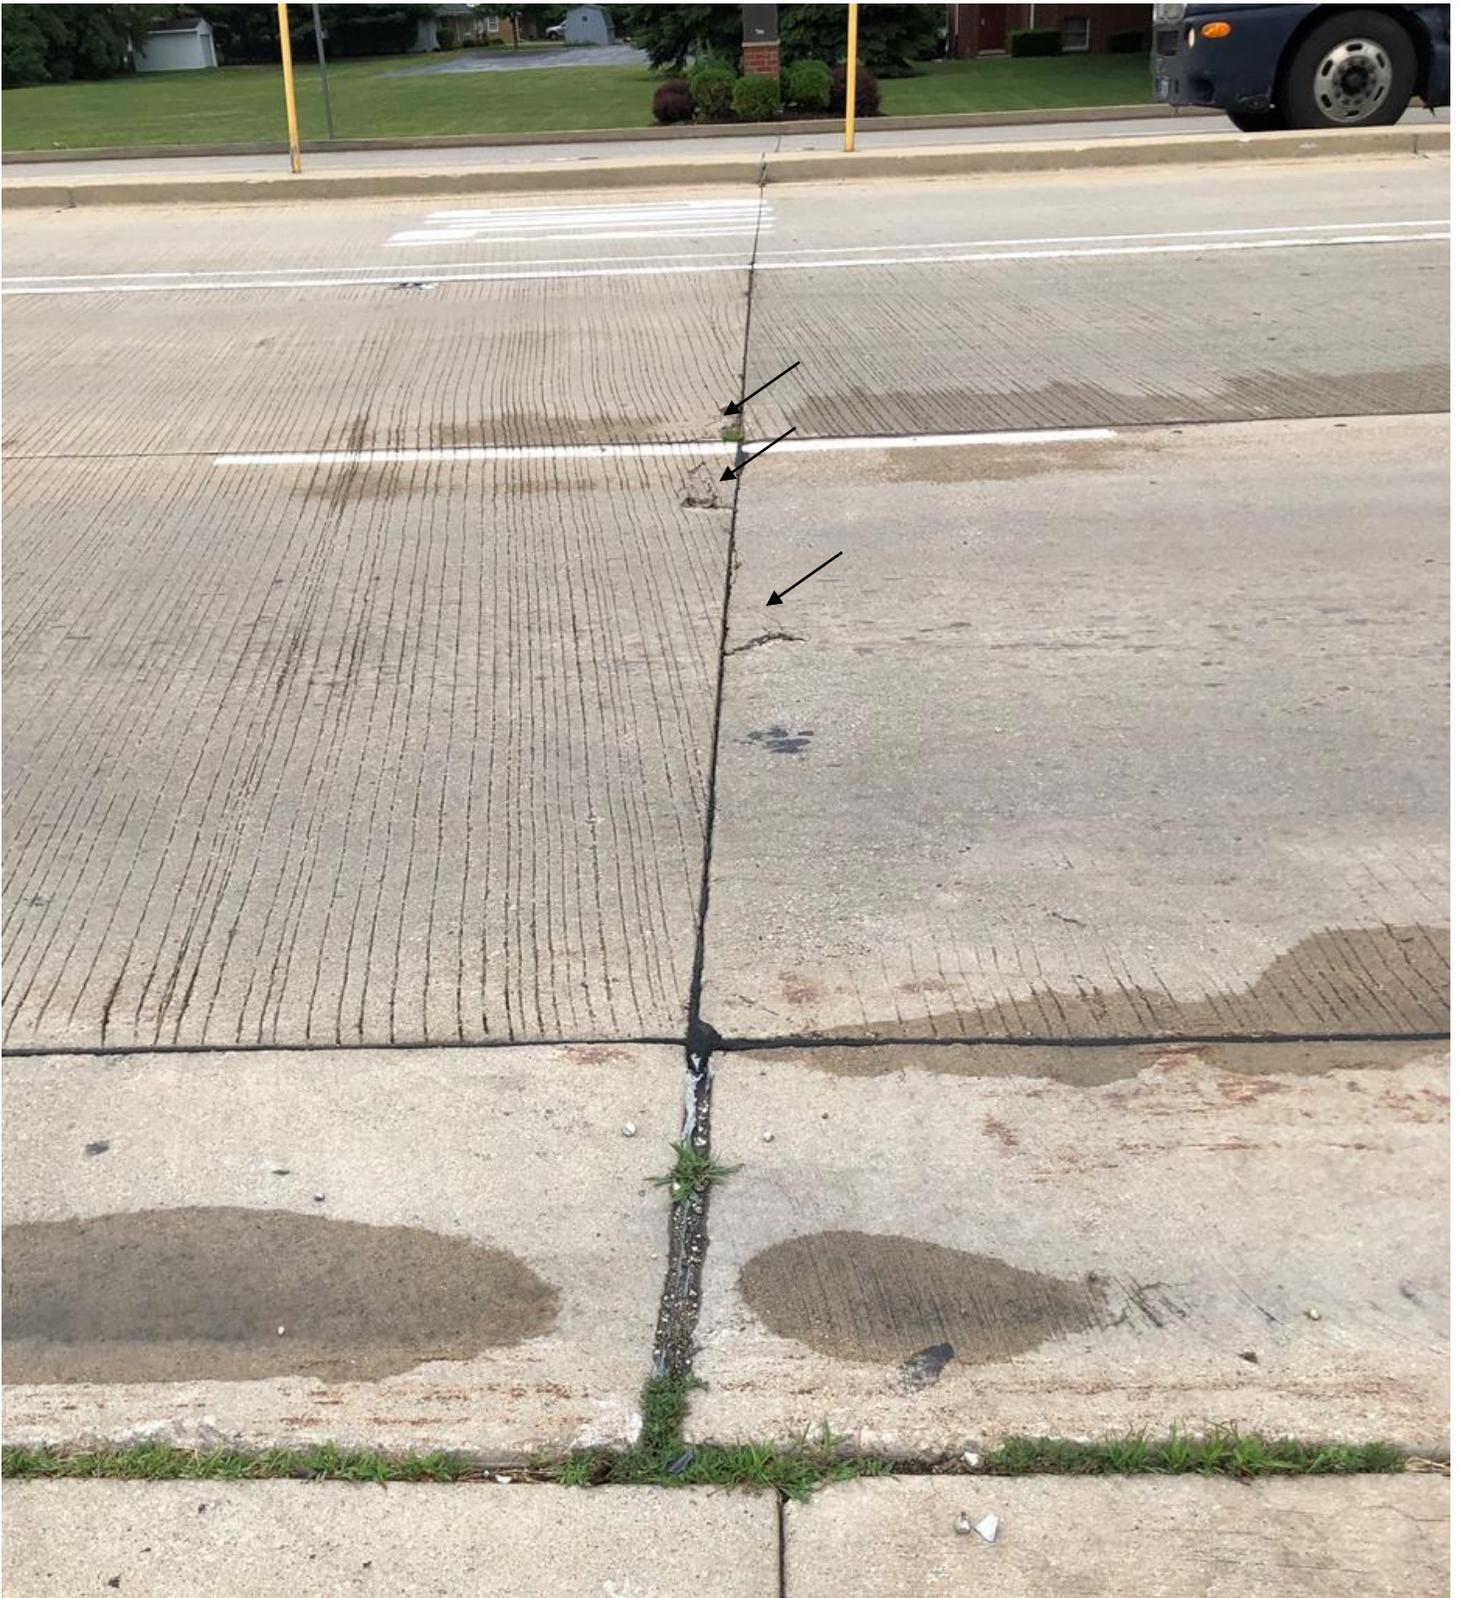
Figure 1-4 Note Delamination Occurring and Lack of Tining on Right Side of Joint

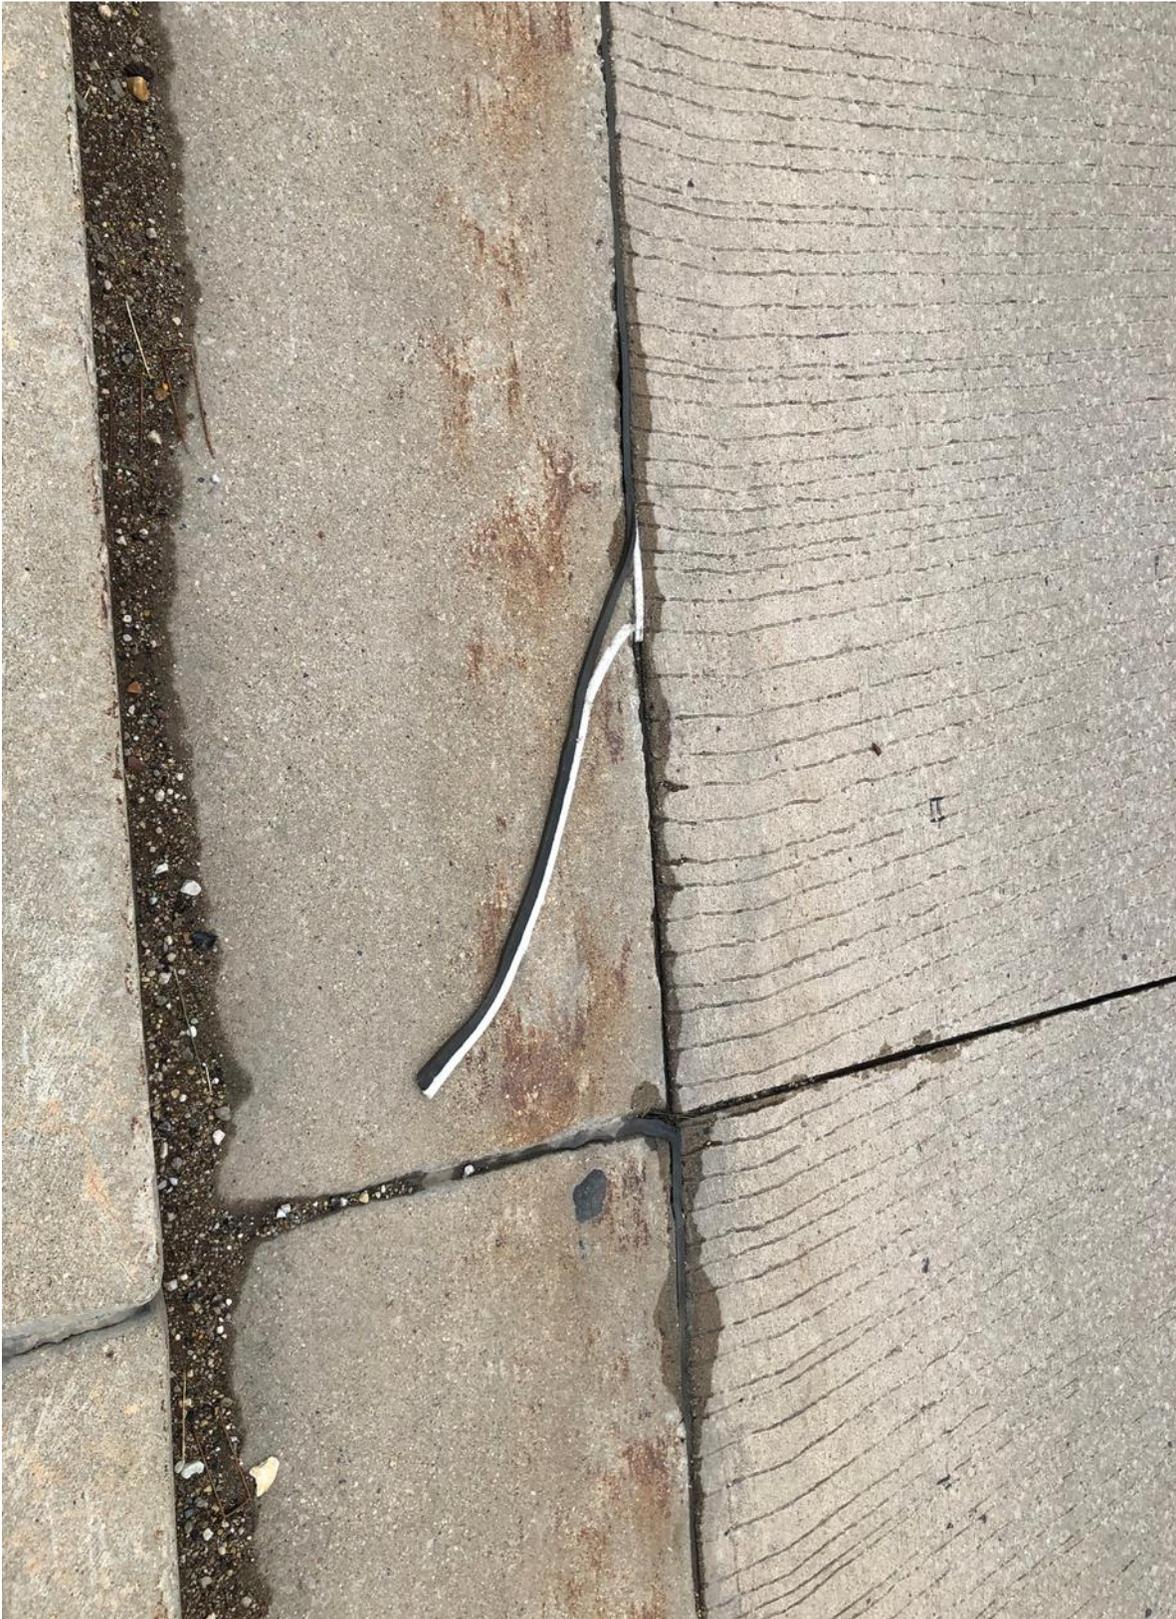
Figure 1-5 Note That Backer Rod Continues to Bonds to the Sealant

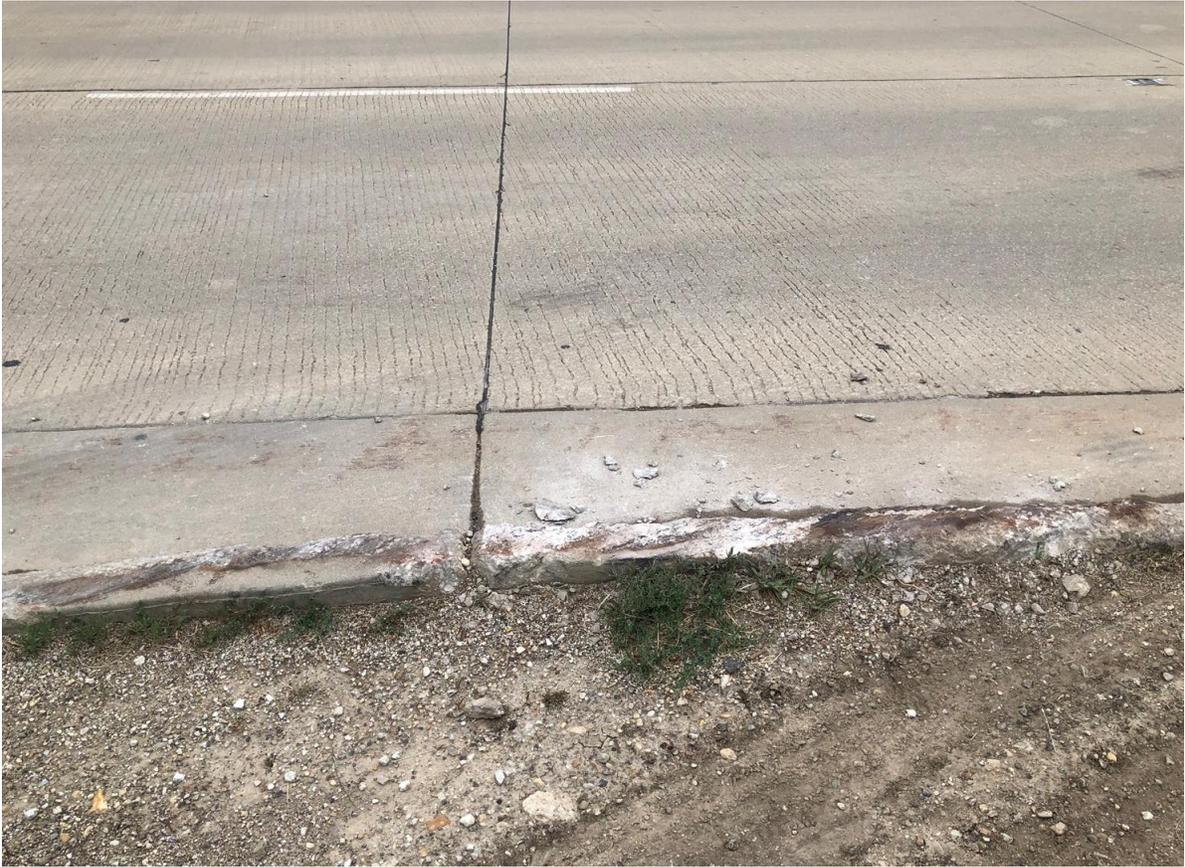
Figure 1-6 Curb Damage and Construction Debris at Approximately 3232+00
