TRANSVERSE JOINT DISTRESS AND MID-SLAB CRACKING DISTRESS IN PCC PAVEMENTS A PETROGRAPHER'S PERSPECTIVE

David Lankard

Dr. David Lankard, President and Petrographer, Lankard Materials Laboratory, Inc., 400 Frank Road, Columbus, OH 43207. lm12@netwalk.com. Proceedings of the 10th International Conference on Concrete Pavements, July 8-12, 2012, Quebec City, Quebec, Canada. www.concretepavements.org.

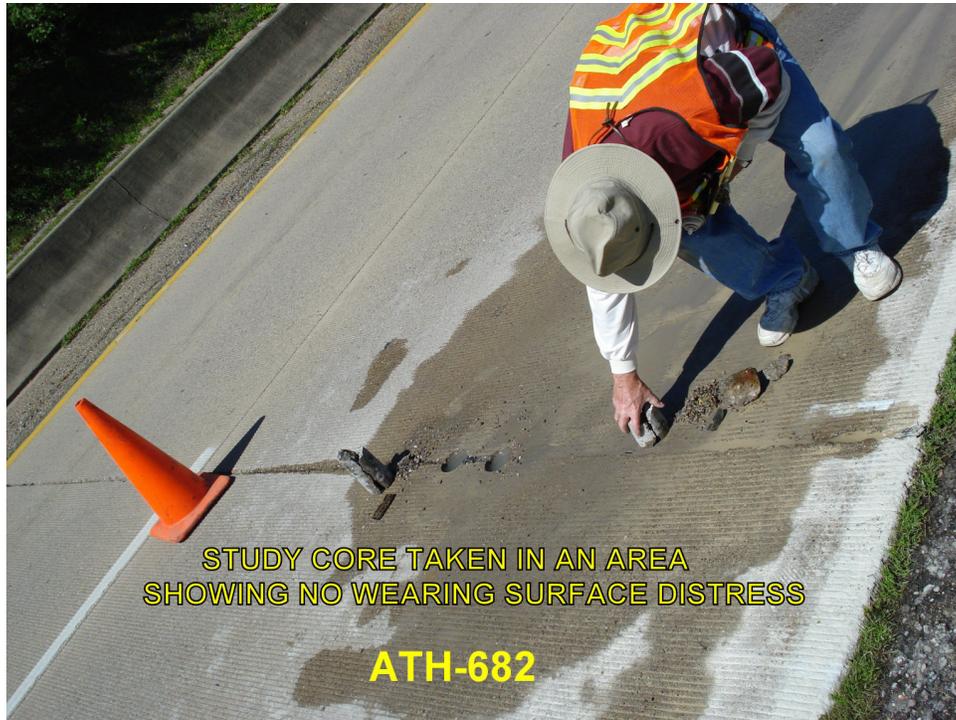
The joint cores were taken at a location along transverse control joints where no joint deterioration was manifest on the wearing surface at the time of coring. An example is shown in Figure 2, which shows coring sites along a transverse control joint on State Route 682 in Athens County, Ohio in the southeastern part of the state. A saw-cut surface of the joint core is shown in Figure 3.

Figure 2. Joint coring sites along a transverse control joint on PCC pavement on SR 682 in Athens County, Ohio (placed in 1976, photographed in 2009).

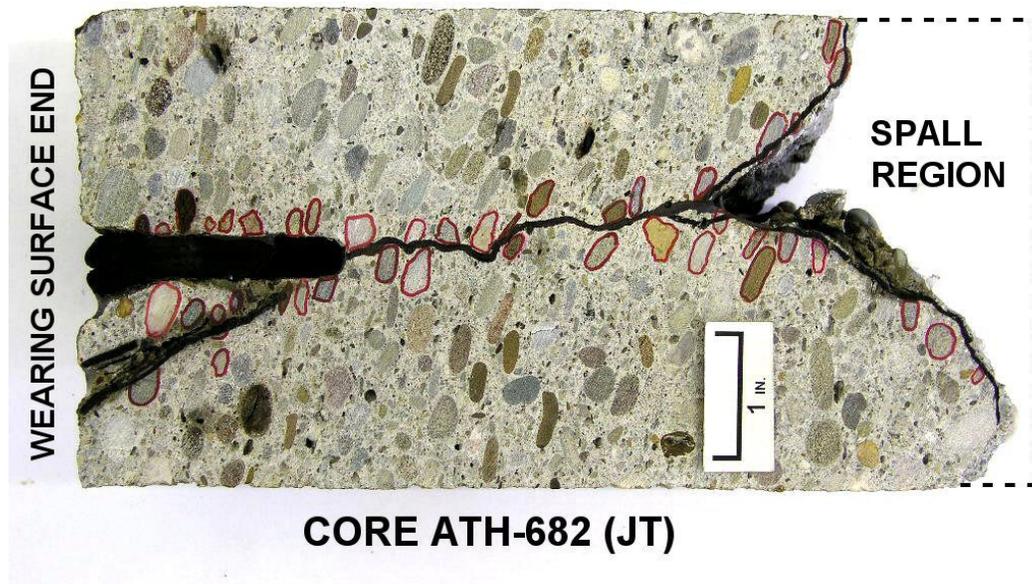
The SR 682 core shows cone-shaped cracking (in this case a spall) that was identified in Figure 1 as Type 2 cracking. This core also shows a near-surface crack identified in Figure 1 as Type 3 cracking. The coarse aggregate particles along the joint crack in Figure 3 have been highlighted in red to show that the joint crack passed around, rather than through the aggregate particles. There is no aggregate interlock.

Figure 3. Saw-cut surface of the joint core taken from State Route 682 in Athens County, Ohio in 2009.

The bottom portion of the SR 682 core that has been lost as a result of the Type 2 cracking is the spall region in Figure 3. The petrographic evidence confirms that the cracking here is due to freeze/thaw distress within the cementitious phase of the concrete, despite the fact that the concrete is satisfactorily air entrained.

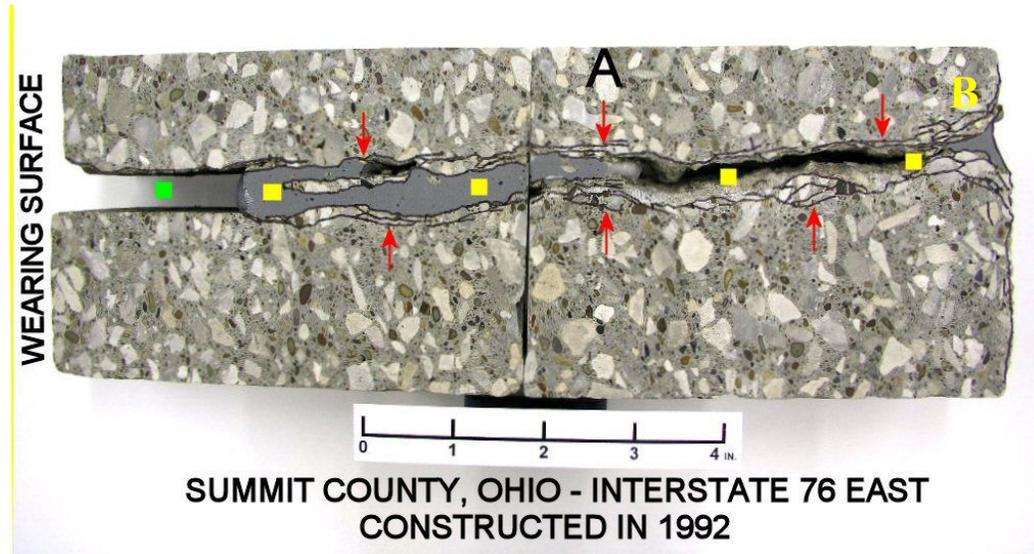
Figure 4. Lapped surface of the joint core taken from Interstate 76 East in Summit County, Ohio, showing sub-surface cracking and spalling distress.

The red arrows in Figure 4 point to Type 1 cracks (highlighted in black) that are present throughout the length of the core (under the joint saw-cut). The yellow dots are placed on void spaces (now partially filled with gray epoxy) where cracked concrete spalled and was lost during the coring operation. At the bottom end surface of the core is the beginning of a cone-shaped Type 2 cracking and spall region.

The green dot in Figure 4 is placed within the joint saw-cut cavity. At this coring site, there is no adhesive bonding the pre-formed rubber sealant to the concrete and it easily dislodged during subsequent handling of the core.

The Type 1 cracks in the I-76 core are due to the effects of freezing and thawing at this coring site along the joint. Photographs taken at a 10X and 7X magnification at Sites A and B on the lapped surface of the I-76 core shown in Figure 4 are shown in Figures 5 and 6 (stereomicroscope views).

The Cracking in the Joint Cores is Freeze/Thaw-Related The cracking shown in Figures 4, 5, and 6 for the Summit County, Ohio I-76 joint core is characteristic of cracks that were initiated within the cementitious matrix and not within the coarse aggregate particles (in this case a 10 mm [³/₈ in] dolomitic limestone. When F/T cracking is initiated within the aggregate particles (as in D-Cracking), the cracks are randomly oriented within the particles, often intersect each other, and the crack planes frequently are parallel to the external surfaces of the particle, just below the surface.

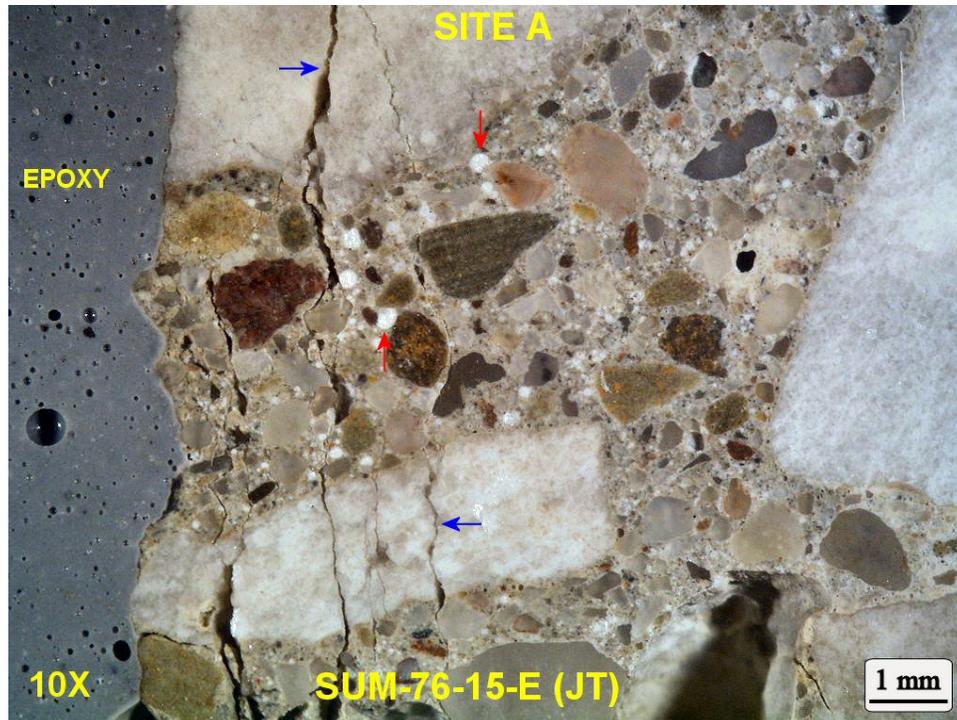
In Figure 5 (Site A in Figure 4) the blue arrows point to two of the Type 1 cracks in the concrete adjacent to the spalled area (which is filled with the gray epoxy in the photograph). The red arrows point to two of the numerous spherical entrained air voids that have been filled with white secondary deposits (innocuous ettringite).

Figure 5. Enlarged view (10X) of the lapped surface of the I-76 core at Site A in Figure 4. The wearing surface is at the top in the photograph.

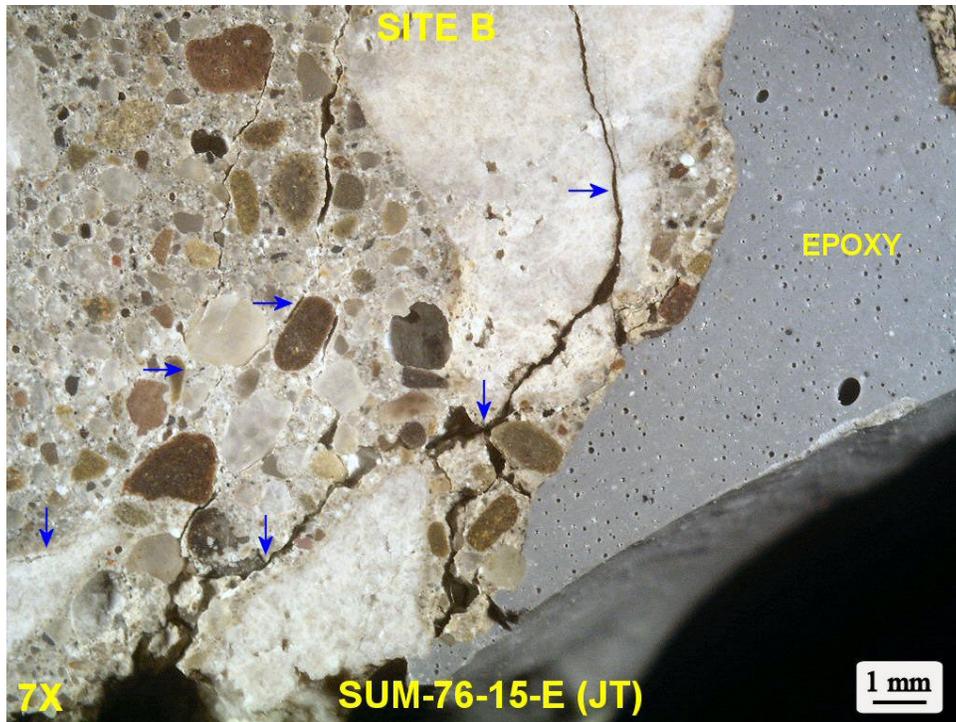
In Figure 6 (Site B in Figure 4) the blue arrows point to Type 2 cracks that have formed in concrete along the bottom end surface. The gray epoxy in this photograph fills the small cone-shaped spall volume. Here too, the entrained air voids are filled with innocuous secondary deposits.

Figure 6. Enlarged view (7X) of the lapped surface of the I-76 core at Site B in Figure 4 (along the bottom end surface of the core).

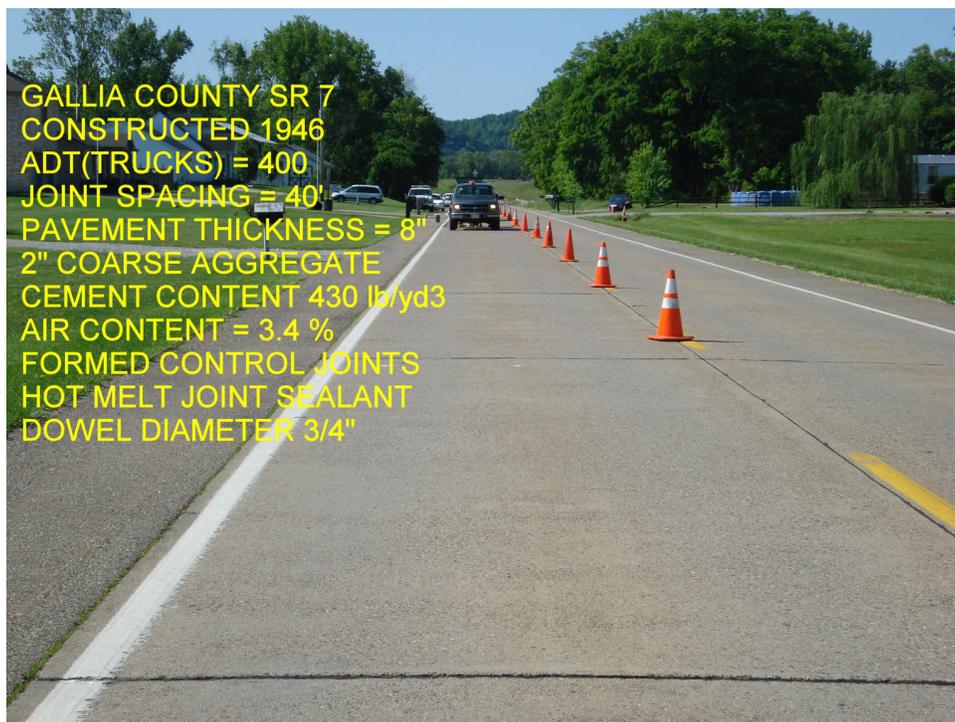
Figure 7. State Route 7 in Gallia County, Ohio. Photograph taken in 2009.

The field notes recorded in 2009 when this 4 km stretch of SR7 in Gallia County was inspected and cored read “Pavement is in good condition with a few minor transverse cracks and spalling”. A close look at the photograph of the pavement in Figure 7 provides verification of this assessment. Quite a few of the 12 m (40 ft) long panels show no surface distress of any kind. The hot-melt sealant in many of the transverse control joints is in good condition for the full width of the joint and is bonded to the concrete on both sides of the joint.

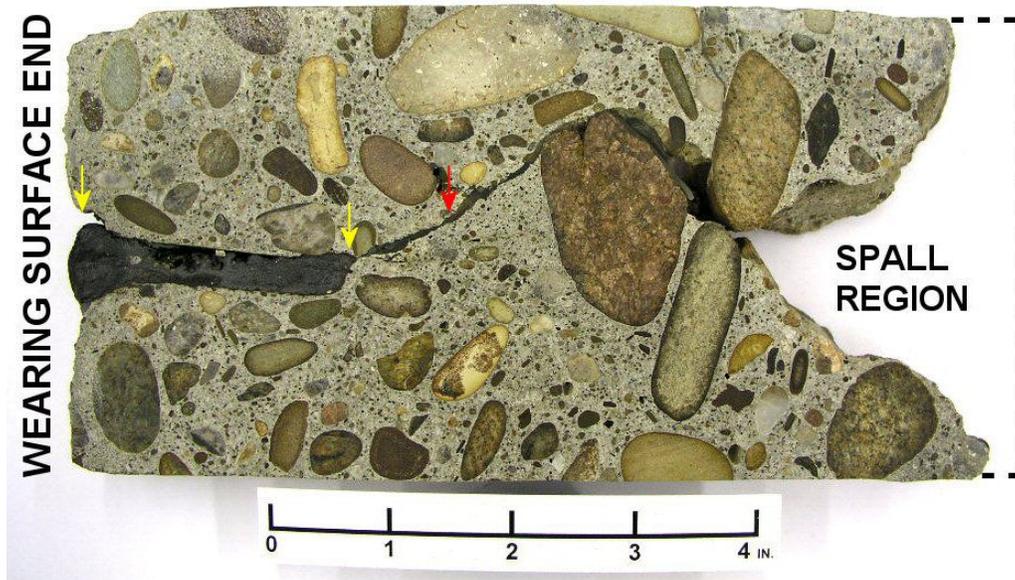
The yellow arrows in Figure 8 define the top and bottom of the original formed joint cavity, which is around 6 cm (2 ¼ in) deep. In addition to filling the formed cavity, the hot-melt sealant has penetrated almost 2.5 cm (1 in) into the joint crack. The red arrow in Figure 8 identifies the depth of penetration of the sealant into the joint crack.

Figure 8. Lapped surface view perpendicular to the plane of the wearing surface in the Gallia County, Ohio SR 7 joint core. This is the original joint that was placed in 1946.

The joint sealant retains its elastomeric properties and was well bonded to the concrete when the core was taken. The only sub-surface distress in the core is the Type 2 cone spall at the bottom of the core. This freeze/thaw-related distress occurred as a result of the concrete in this portion of the slab experiencing water ponding along the bottom of the slab. Although the concrete is air-entrained, the total air void content is low (3.4 percent), and the spacing factor is moderately higher than desired at 0.24 mm (0.0097 in). The air voids in the vicinity of the spall are filled with secondary deposits. The petrographic evidence from the core suggests that the source of the water that ponded along the bottom of the slab over the years came from the base and not from the slab surface.

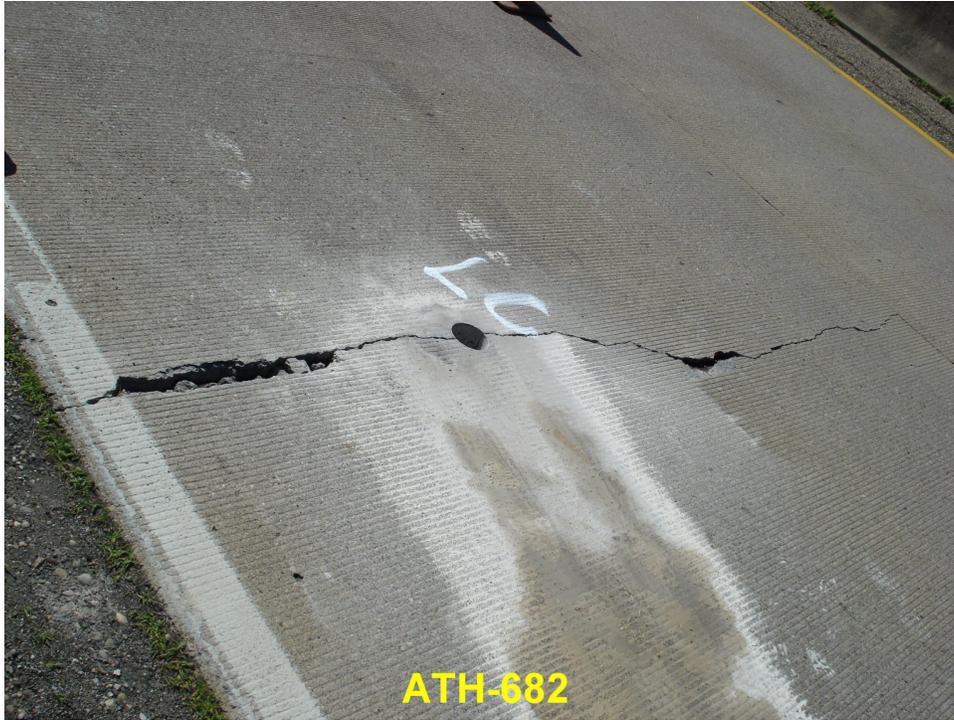
Figure 9. The coring site along a mid-slab crack on PCC pavement on State Route 682 in Athens County, Ohio. Photograph taken in 2009.

There is some of the Type 3 surface cracking and spalling in the portion of the crack closest to the shoulder, where moisture accessibility would be higher than in the center of the slab. The core at this site was taken at a location where there is no manifest distress in the wearing surface. This core is in good condition and shows only a minor amount of the Type 2 cracking along the bottom end surface.

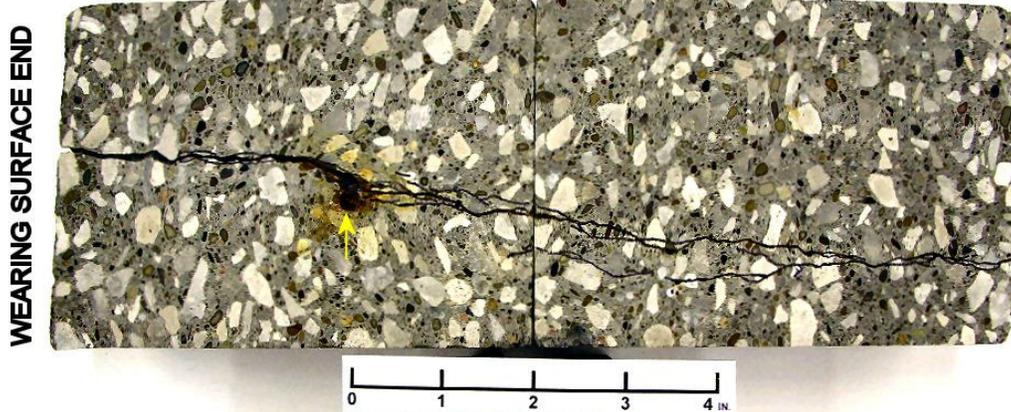
SUMMIT COUNTY, OHIO - INTERSTATE 76 EAST

Minor Type 1 Cracking Distress in a Mid-Slab Crack Core Figure 10 shows a lapped surface of the mid-slab crack core from the Summit County, Ohio, Interstate 76 East pavement. The concrete in the vicinity of the crack fracture plane shows the same distress features as described in Figure 5. The total air void content of the concrete is 6.3 percent with an air void spacing factor of 0.12 mm (0.0050 in).

Figure 10. Lapped surface of the mid-slab crack core taken from Interstate 76 east in Summit County, Ohio. Type 1 cracks in the core are highlighted in black. The arrow points to a mesh strand, which shows a minor amount of rust.

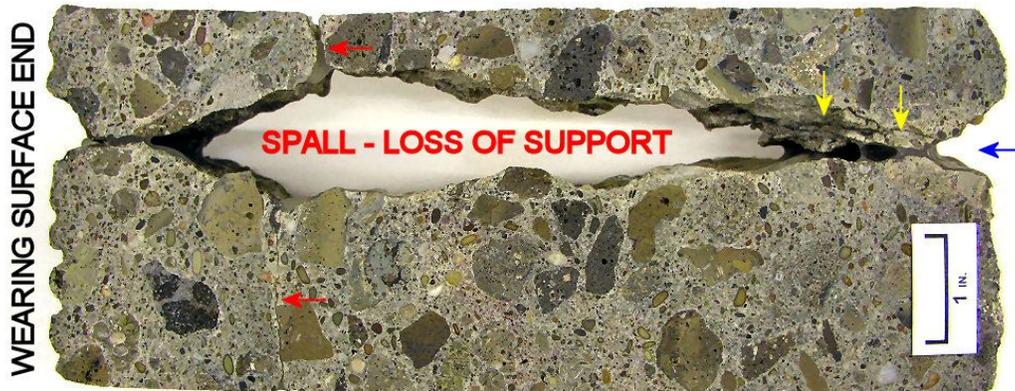
JEFFERSON COUNTY, OHIO STATE ROUTE 7

Significant Amount of Type 1 Cracking in a Mid-Slab Crack Core The core taken through a mid-slab crack on State Route 7 in Jefferson County, Ohio shows the greatest amount of sub-surface distress of any of the mid-slab crack cores. Figure 11 is a lapped surface of the core, which has a blast furnace slag coarse aggregate. The total air void content of the concrete is 6.1 percent with an air void spacing factor of 0.18 mm (0.0071in).

The Type 1 cracking in the Jefferson County SR7 core has led to a significant amount of spalling along the crack fracture plane (Figure 11). I believe that the resultant loss of support in this region of the pavement contributed to the formation of Type 3 cracks (red arrows in Figure 11), which ultimately leads to spalling distress along the mid-slab crack in the wearing surface. Figure 12 shows an example of the Type 3 cracking distress feature on the Jefferson County, State Route 7 pavement.

Figure 11. Lapped surface of the mid-slab crack core taken from State Route 7 in Jefferson County, Ohio. This mid-slab crack core shows examples of Types 1, 2, and 3 cracking distress.

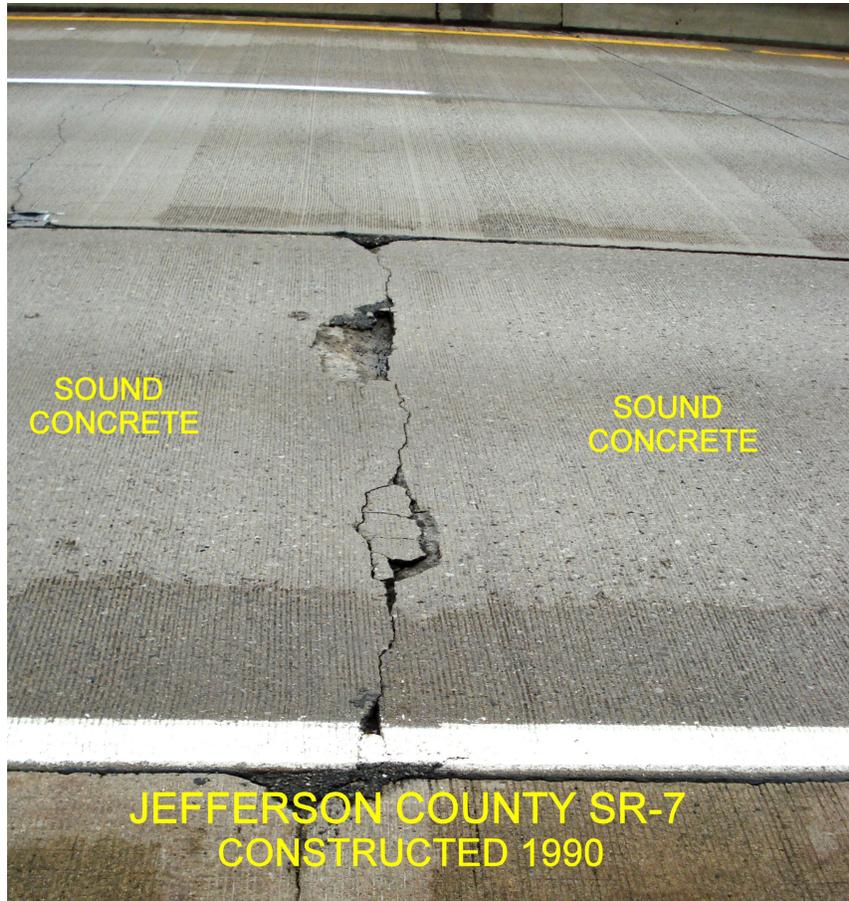
The Type 1 cracking in the Jefferson County SR7 core has led to a significant amount of spalling along the crack fracture plane (Figure 11). I believe that the resultant loss of support in this region of the pavement contributed to the formation of Type 3 cracks (red arrows in Figure 11), which ultimately leads to spalling distress along the mid-slab crack in the wearing surface. Figure 12 shows an example of this distress feature on the Jefferson County, State Route 7 pavement (not the joint from which the joint core in Figure 11 was taken). Note the sound concrete on each side of the crack.

Figure 11. A mid-slab crack on the Jefferson County, Ohio State Route 7 pavement showing Type 3 cracking and spalling distress (Photographed in 2009).
