Petrographers Perspective of Joint Associated Distress

By Gerard Moulzolf, PG

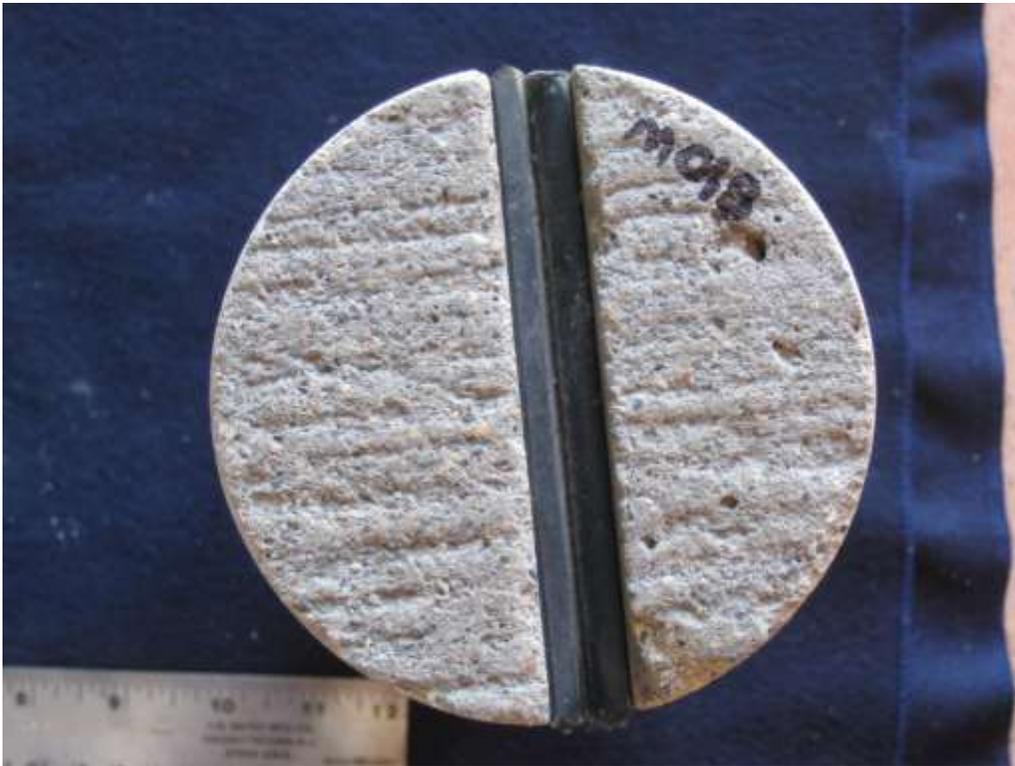
Photo 1: 6" diameter concrete pavement core through a neoprene compression – sealed joint.

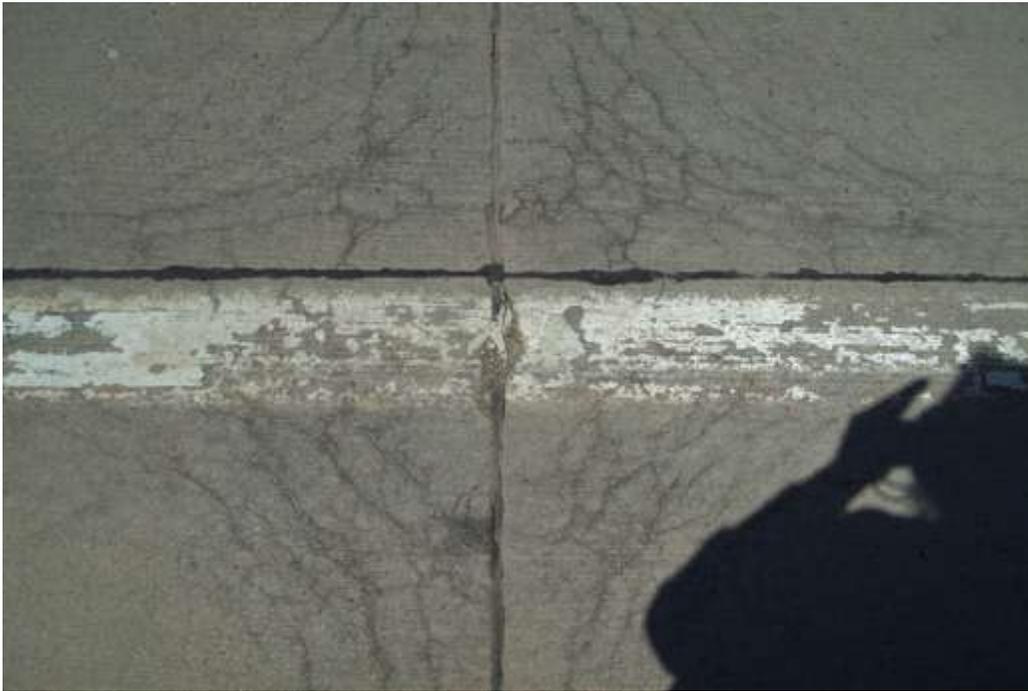
ASR generally produces concentrated cracking directly adjacent and parallel to the pavement joints and panel edges due to the exposure to persistent moisture in the joints (photo 2). Without the benefit of sampling and microscopy, this cracking has been confused with freeze-thaw distress. Cores taken from mid-panel locations in these cases can show little or no active ASR. Other pavements exhibiting ASR can be marked by more widespread map or "craze" cracking over their entire surfaces. This cracking can be confused in the field with a more common shrinkage-induced craze cracking. However, bulk expansion of the slab should be evident in the case of ASR. ASR is sometimes opportunistic or occurs "symbiotically" with freeze-thaw distress in older pavements and occurs only after the concrete "system" has been compromised.

Photo 2: ASR cracking in a Mid-west pavement containing reactive quartzite coarse aggregate.

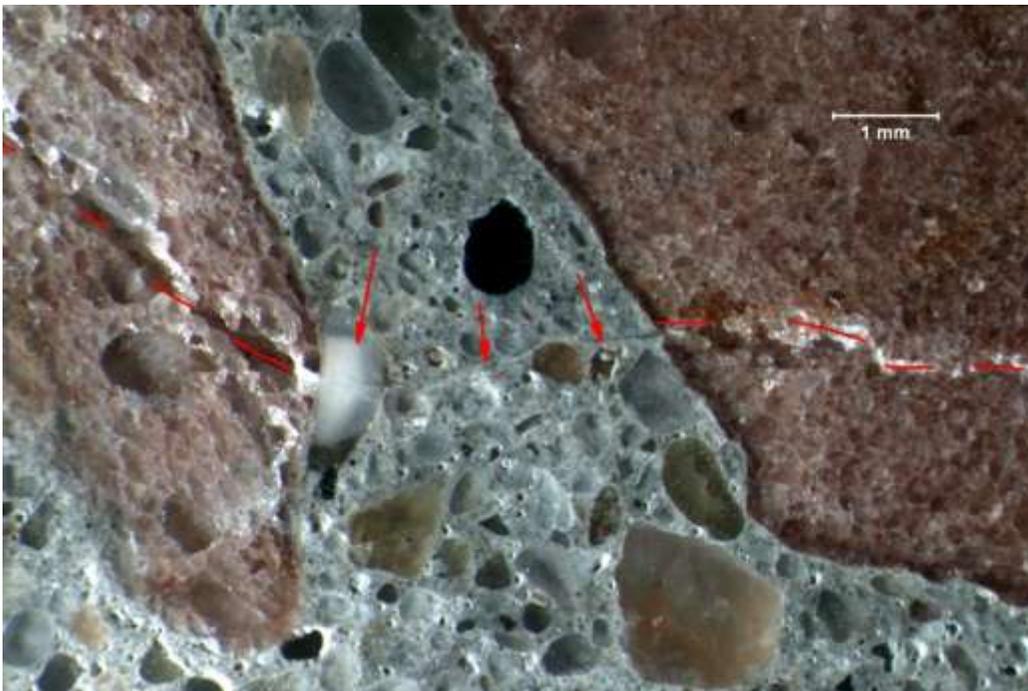
The reaction between alkalis in the paste and the reactive silica in the aggregates produces an expansive silica gel product which induces cracking and bulk expansion in the concrete (photo 3). The gel product is hygroscopic; absorbing more water after formation to continue its growth. The reaction requires alkalis, reactive silica, and moisture. Eliminating or reducing any one of the components may prevent the reaction. Unfortunately, alkalis and moisture cannot be avoided in concrete pavement. The use of low alkali cements and pozzolans such as Class F flyash have been successful in mitigating ASR. Pozzolans can mitigate the ASR reaction by reacting with and eliminating the alkalis by incorporating them into the subsequent additional cementitious binder.

Photo 3: Clear to white colored ASR gel product fills a void and microcracking adjacent to reacted and cracked coarse quartzite aggregate particles.

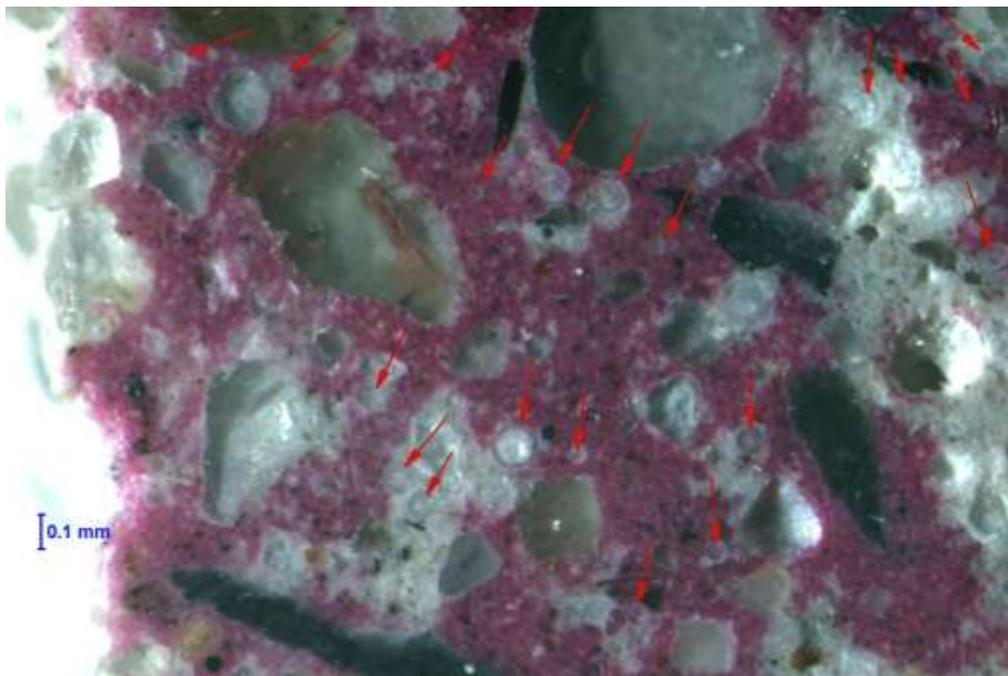
Air-void parameters recommended by ACI for concrete in freeze-thaw environments include volume, spacing factor and specific surface values. The great majority of all concrete pavement placements contain good quality, well distributed air-void systems. Rare, isolated cases of air void loss or segregation in “vibrator trails” have been described. Air void loss during placement has not been observed by this petrographer at slip formed surfaces or early-age sawcut control joints. However, a large apparent loss in air void effectiveness at joints has been observed due to complete in-filling of finer air voids from secondary ettringite. Reductions in air void volumes from 5 or 6% down to 3 or 4%, with a large increase in spacing factor were not uncommon in numerous Midwest pavements studied by this petrographer. Concrete contains all the necessary ingredients to produce secondary ettringite and it is a very common occurrence in voidspaces in concrete exposed to moisture movement. However, the sheer volume and degree of filling of concrete paste directly adjacent to joints and distress planes (vertical scaling) is alarming (photo 4).

Photo 4: Translucent secondary ettringite fills most entrained air voids directly adjacent to a vertically spalled joint surface (L). Paste was stained magenta with phenolphthalein to aid in identifying filled voids.

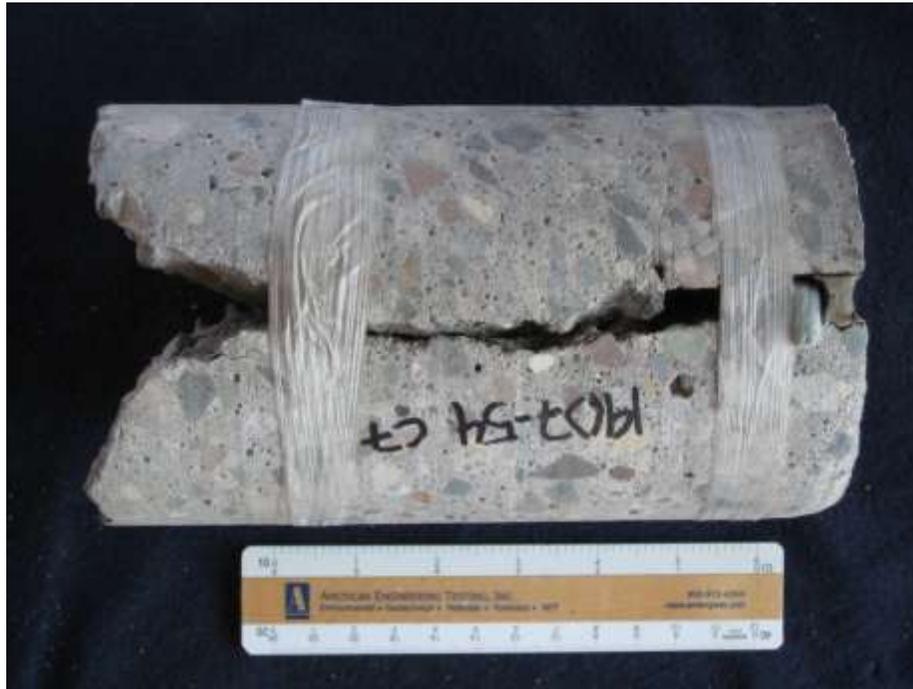
The original distress mechanism postulated by this petrographer and others for the widespread “premature joint failure” encountered by numerous Midwest and Great Lakes state DOT’s at least 15 years ago was the severe loss of “entrained” air void volume and quality directly adjacent to the joints. We believed the distress was cyclic freeze-thaw action on the compromised paste – producing vertical “scaling” or spalling. The distress was progressive. As the paste was cracked, vertically or nearly vertically, commonly in a “conical” or “teepee” – like pattern (photo 5), the further ingress of deicers and identified exterior sulfates produced more ettringite.

Photo 5: Typical distress pattern in Midwest pavement core through joint. Note conical distress pattern at base of core (L).

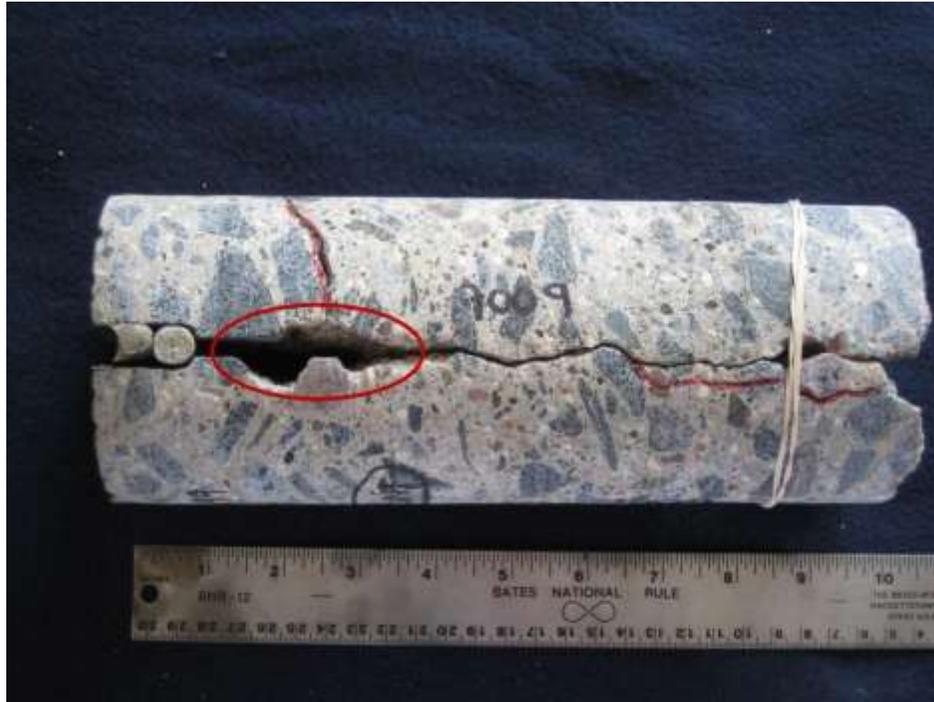
space help hold moisture allowing for the critical saturation to be achieved. The distress starts as a “rounded” zone of compromised concrete paste at the base of the sawcut (in cross section). The term “tunneling” has also been recently used to describe this distress phenomenon. We have seen this initial appearance to the distress in “activated” joints which may have also been in-filled with debris (photo 6). The significant loss of air void volume from secondary ettringite fillings was also identified within the paste directly adjacent to the distress surface.

Photo 6: “Tunneling”: A rounded zone of disintegrated concrete paste at the base of a sawcut and sealed joint (backer rod and silicon).

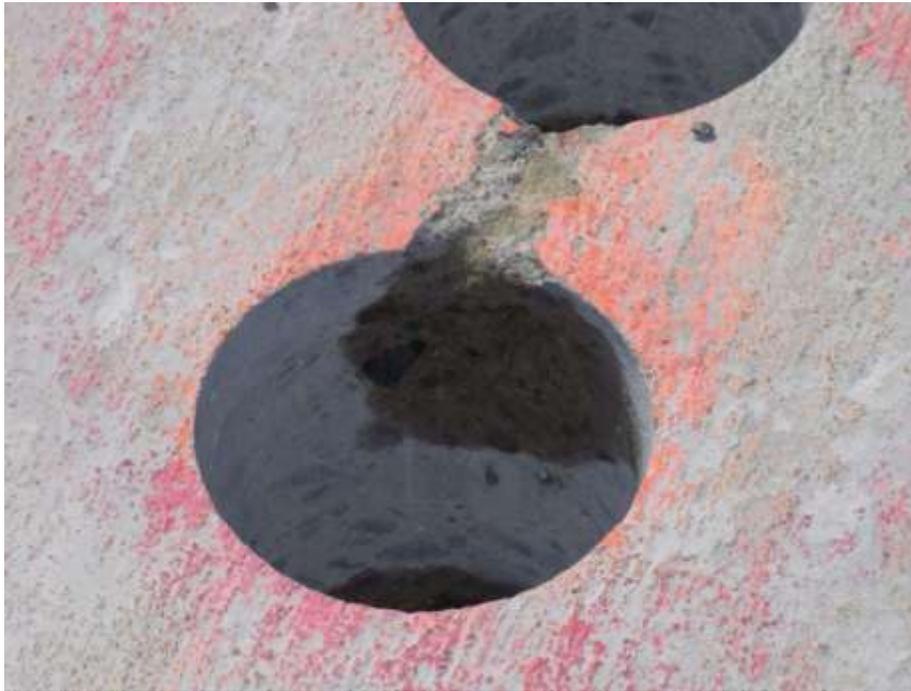
Concrete placed with properties not sufficient for resisting cyclic freeze-thaw and cyclic structural loading is very rare but occasionally occurs. Batching errors, incomplete mixing (photo 8), and inconsistent or sub-standard concrete making materials can produce concrete not meeting the durability requirements of a long – lived pavement. Often, low quality entrained air-void systems are identified by petrography (ASTM C856) and the use of hardened air content testing by ASTM C457. If the concrete is deficient, the distress will often manifest itself at the joints first with little or no distress at mid-panel locations, much like some previously mentioned ASR occurrences.

Photo 8: Incomplete mixing in concrete pavement. Note raveled and saturated mass of concentrated flyash; core-sampled for analysis.
