Maintenance and Longevity of Longitudinal Joints

LARRY GALEHOUSE AND LARRY SCOFIELD

Background on Longitudinal Joint Maintenance

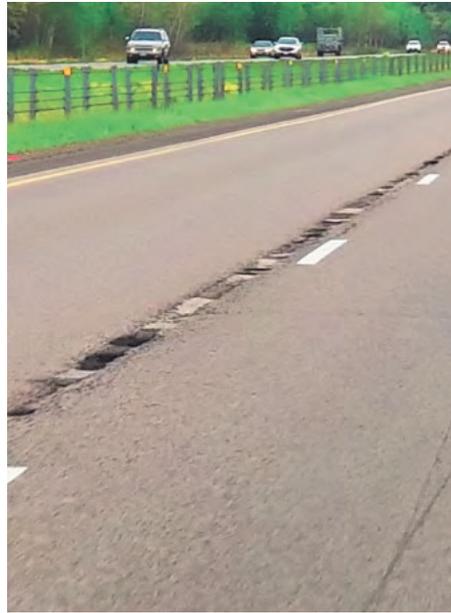
Before repair, the ride was rough—and potentially dangerous—along a stretch of Interstate 35 in Minnesota, where, in some spots, cracks along longitudinal joints were inches deep and several inches wide.

much as three inches wide and four inches deep.

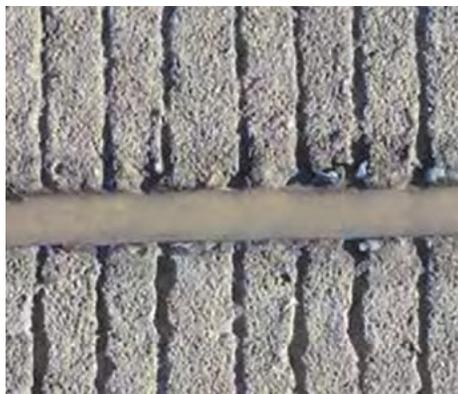
The takeaway from the Arizona SPS-2 experiment is that silicone joint sealant had exceptional performance and lasted more than 20 years with no maintenance. At the other SPS-2 locations, the silicone sealant was not as effective and

Standing up to the test of time—and daily use, the silicon joint sealant applied during the Arizona SPS-2 experiment has lasted more than 20 years without maintenance.

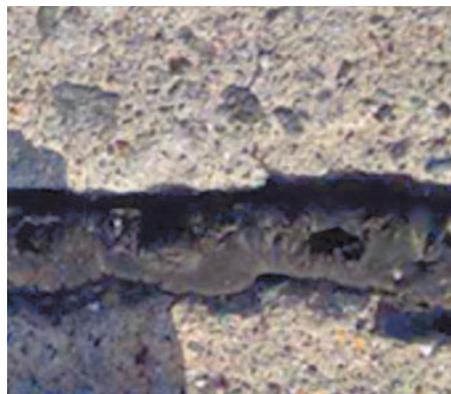
During the hot-pour sealant installation at Washington's Fairchild Air Force Base, moisture bubbles formed in the mix. Still, after 21 years, the sealant performed well.

service the hot pour with bubbles was still performing well.

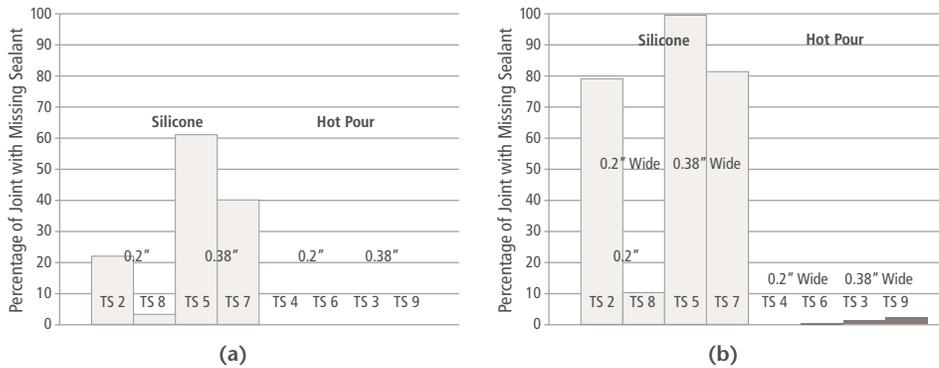
FIGURE 2 Percentage of joint sealant missing from transverse joint with (a) 2013 and (b) 2021 data (TS = test section).

Figure 2 presents the results from the 2013 and 2021 visual assessments of missing sealant. The 2013 results indicate that material type was already a factor in performance. That is, hot-pour sealant was outperforming silicone sealant after just four years in service. The silicone sections indicated the effect of joint width, specifically that the narrow joint width was outperforming the wider joint width. The value of having replicate test sections also was evident, as Test Section 2 and Test Section 8 were performing differently but should have had similar performance.

The 2021 test results continue to support the 2013 test conclusions: Hot-pour sealants significantly outperformed silicone sealants. Narrow width joints outperformed wider width joints, and Test Section 2 and Test Section 8 exhibited even larger performance disparities.

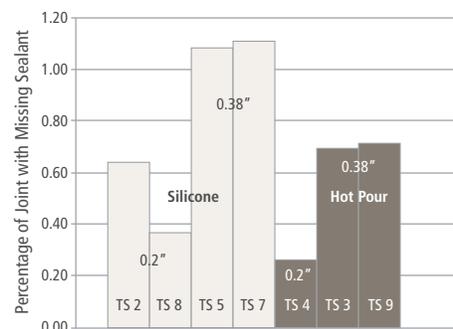
FIGURE 3 Shape factor of test section sealant installations.

However, as indicated in Figure 3, the narrow sealant installations had the worst shape factor by far, yet the best performance. This is true for hot pour, as well as silicone installations.

One explanation for this is the possible impact of vertical forces on the sealant surface. For silicone sealants, a flush-filled condition will fail quickly in the wheelpaths due to contact with tires. This is why silicone sealant should be installed in a recessed condition. In situations that involve snow, ice, or high rainfall, vertical forces also may be transferred to the sealant surface through snow and ice or hydrostatic pressures beneath the tire. If this assumption is true, there may be an optimum
