Tech Brief

Evaluation of Backer Rod Absorption

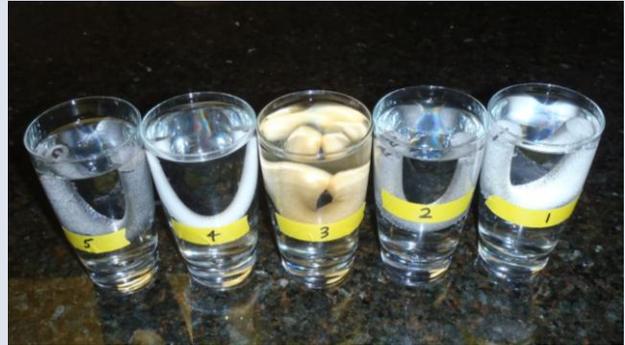
Figure 1 Backer Rods Submerged in Tap Water

The experiment consisted of submerging six inch long specimens of each backer rod type into a glass of tap water and removing and weighing the backer rods at periodic intervals. The scale used to weigh the samples was accurate to 0.005 lbs which is approximately the weight of a dime or a 6" by 11" paper towel. Figure 1 is a photo of the samples submerged below the water level in each glass.

Initially, five backer rods were submerged in water in excess of 87 hrs and weighed periodically to determine the absorption. The four closed cell backer rods indicated no absorption, while the open cell rod indicated a significant absorption. Upon completion of the submerging phase, the samples were placed in a freezer for five days and then removed. The four closed cell samples remained flexible while the open cell material broke in half when bending was attempted. Figures 2 & 3 indicate the backer rods after freezing.

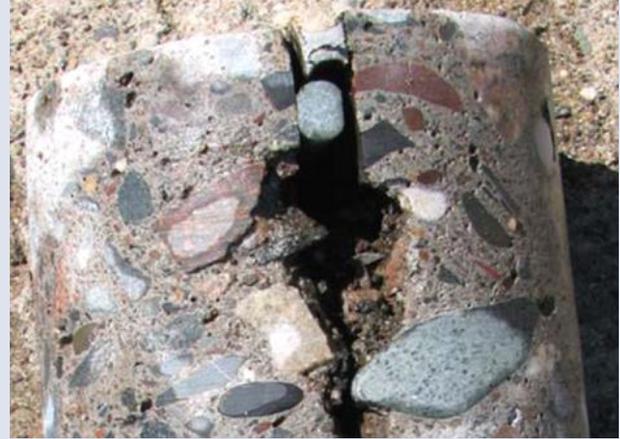
Figure 4 Joint Distress Beneath Backer Rod (Courtesy MnDOT)

Traditional backer rod design and installation places the backer rod in a horizontal

position throughout the joint as indicated in Figure 4. With this placement, it is possible for water to enter the shoulder joint and drain back into the reservoir cut and deteriorate the joint below the backer rod as indicated in Figure 4.

The distress indicated in Figure 4 is also possible if the seal is breached and water ponds beneath the closed cell backer rod.
