Evaluation of Concrete Pavement Buckling in Wisconsin

Applied Research Associates, Inc.

WisDOT ID No. 0092-20-02

February 2022

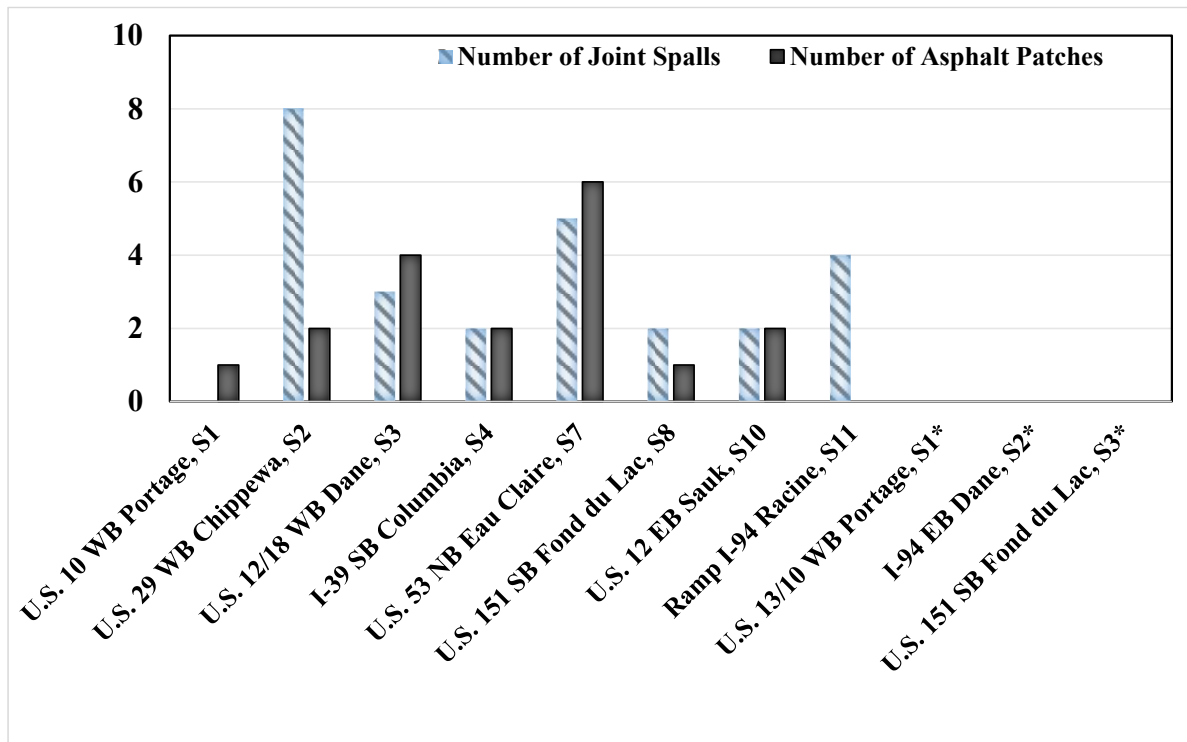
Figure 11. Number of transverse joint spalls (width of spall ≥ 1.0 inch) and asphalt patches over a 1,000-ft section for buckling and control sites.

The conditions of transverse joints were evaluated through visual inspection and coring for buckling and control sites. The number of joint spalls and asphalt patches were recorded as shown in Figure 11.

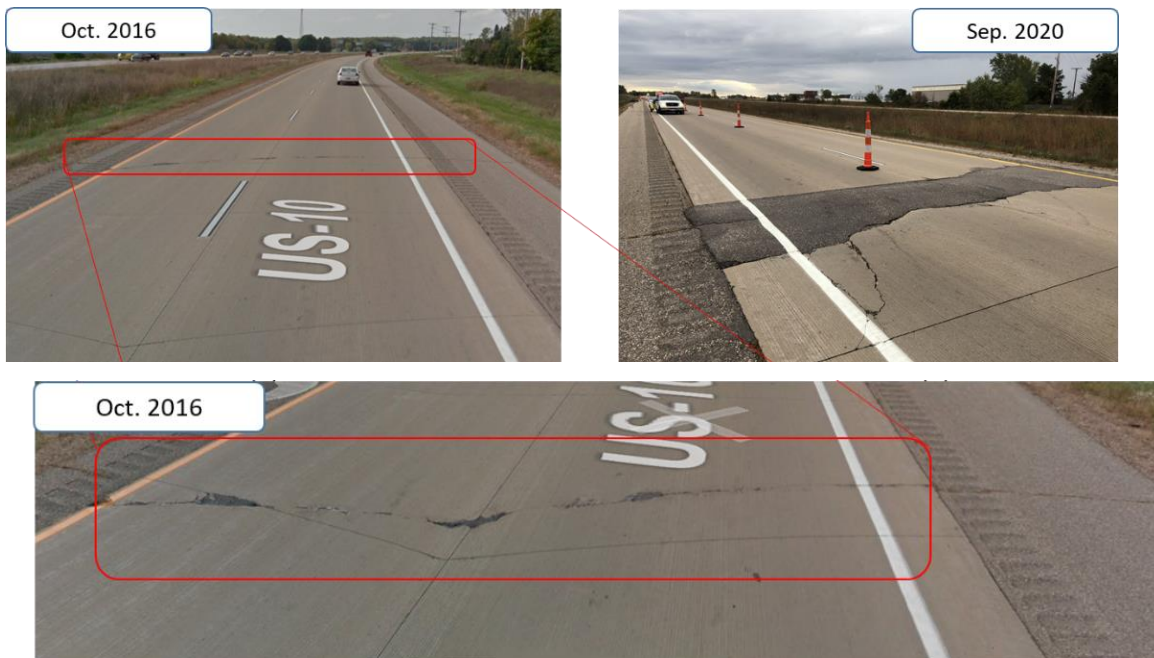
Figure 13. Google Earth® images of U.S. 10 in Portage county (site # 1) prior to buckling showing spalls, shoulder cracking, and asphalt patching (left and bottom). Image on the right, collected during the September 2020 field survey shows the same location patched with full-depth asphalt following the blowup.

This evidence is further supported by the research team’s review of historical Google Earth® images for the buckling sites. For example, U.S. 10 in Portage County (site # 1) surveyed in September 2020, had exhibited one blowup over a 1,000-ft. section. An October 2016 image showed a transverse crack/joint that exhibited spalling and maintenance patching (Figure 13). A transverse crack also developed in both asphalt shoulders. On May 27, 2018 a blowup occurred across both traffic lanes at this crack/joint. This area was then patched with asphalt across both traffic lanes. There was no apparent deterioration of adjacent joints. In this case, buckling appeared to have occurred at a deteriorated joint with spalling, asphalt patching, and cracks.

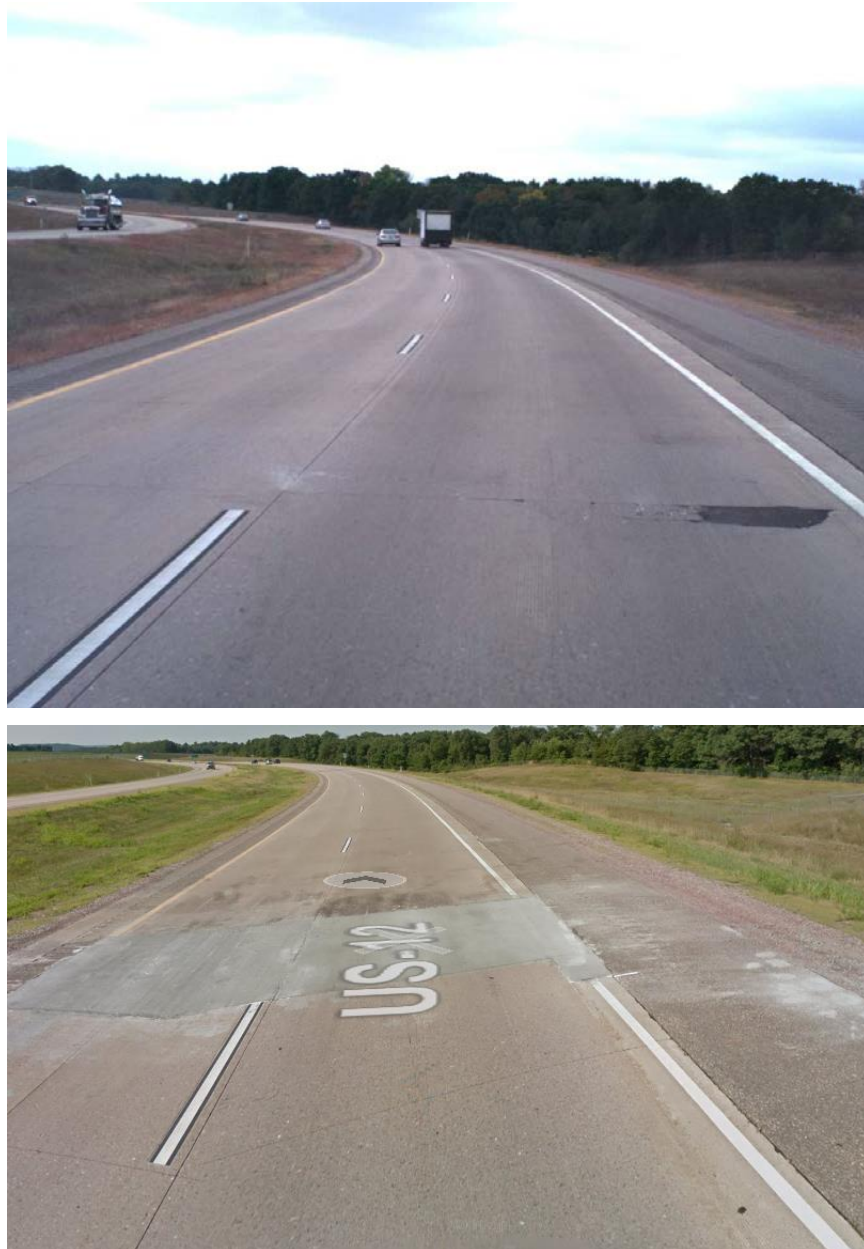
Figure 14. October 2017 Google Earth® images of U.S. 12 prior to buckling showing spalls and asphalt patching (top). July 2018 Google Earth® image of the same joint following buckling (bottom).

Another example of a joint that exhibited spalling and maintenance patching in October 2017 prior to the blowup is presented in Figure 14. Image after buckling dated July 2018 shows a blowup occurred and a full-depth repair was placed across both traffic lanes as a repair for the buckled joint. In both these examples, the deterioration of a joint either contributed to or was a precursor pointing towards future buckling.

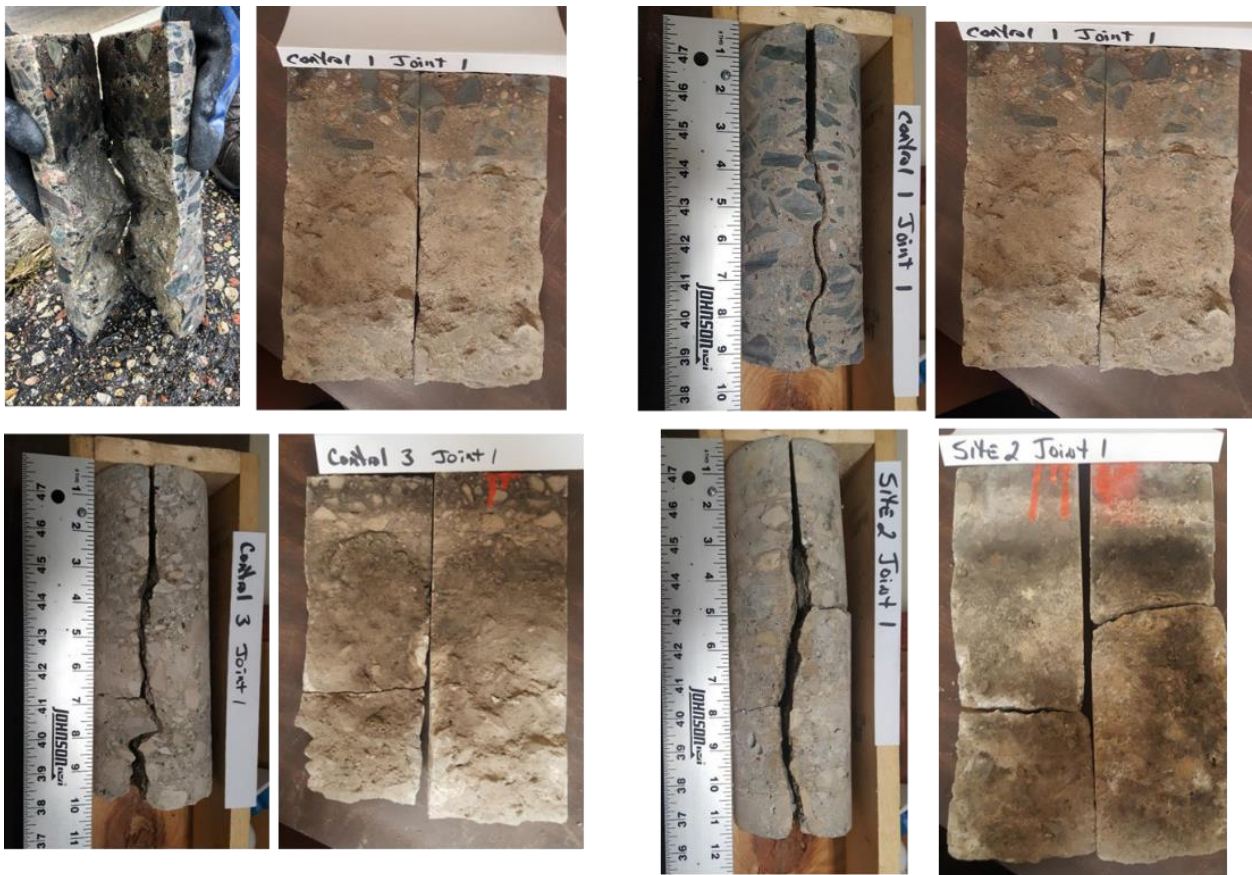
Figure 16. Cores from control sites taken from transverse joints and core holes showing no spalls in the lower portion of the joint.

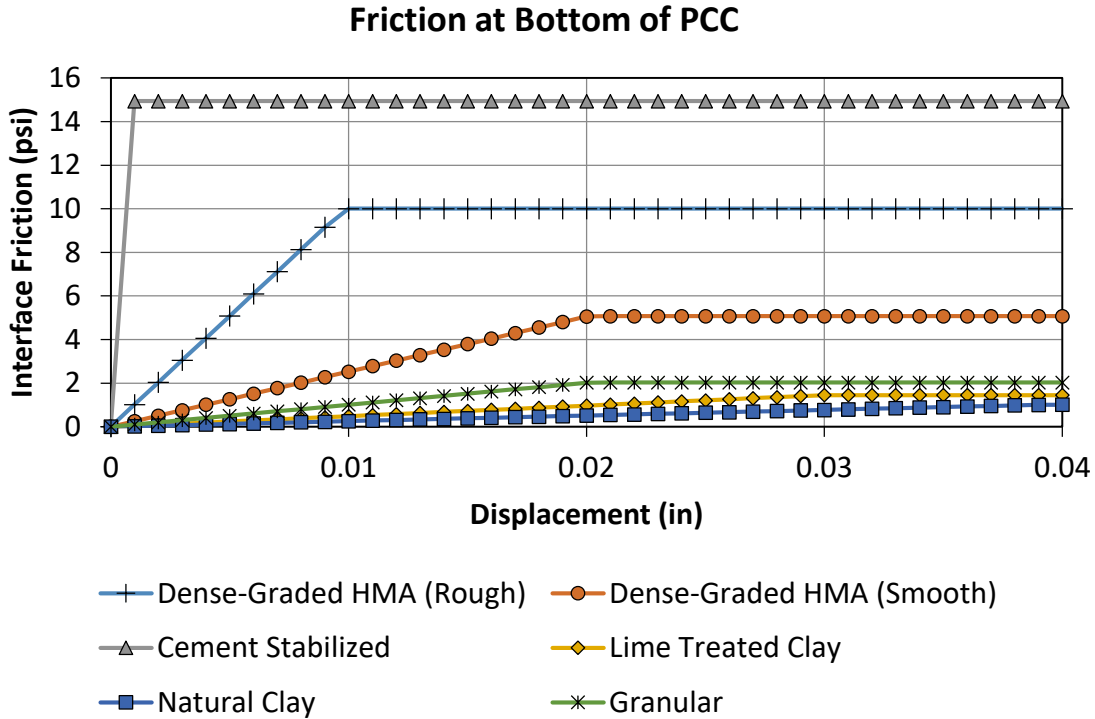
Figure 30. Friction at PCC slab and base interface.

Figure 30 shows the bilinear model of friction at the bottom of PCC layer for different foundation types (Roesler and Wang 2011). The bilinear friction model was consistently used in both the analytical model for joint opening/closing and buckling.

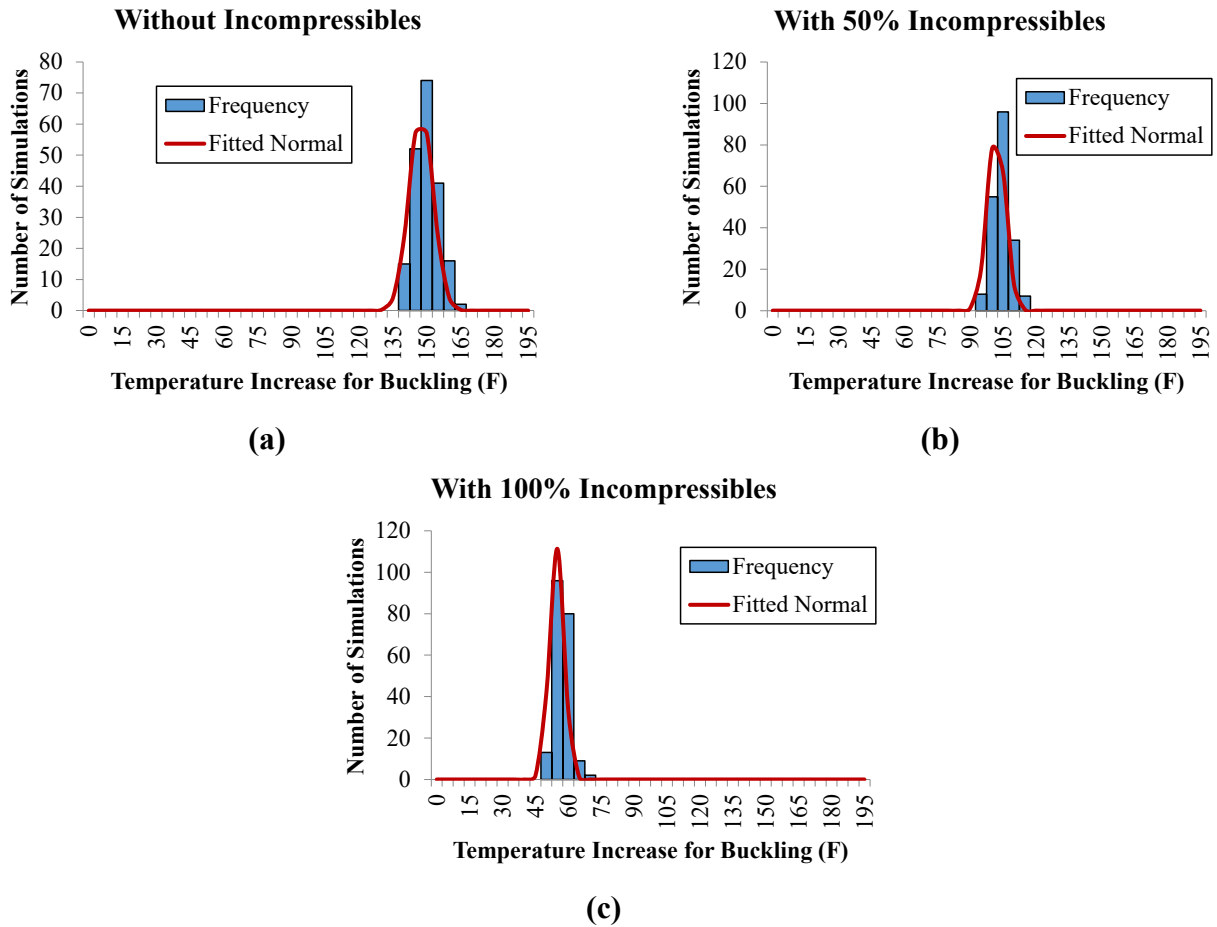
Figure 31. Equivalent temperature increase needed for buckling with (a) 0 percent, (b) 50 percent, and (c) 100 percent incompressible materials within the joint (granular base).

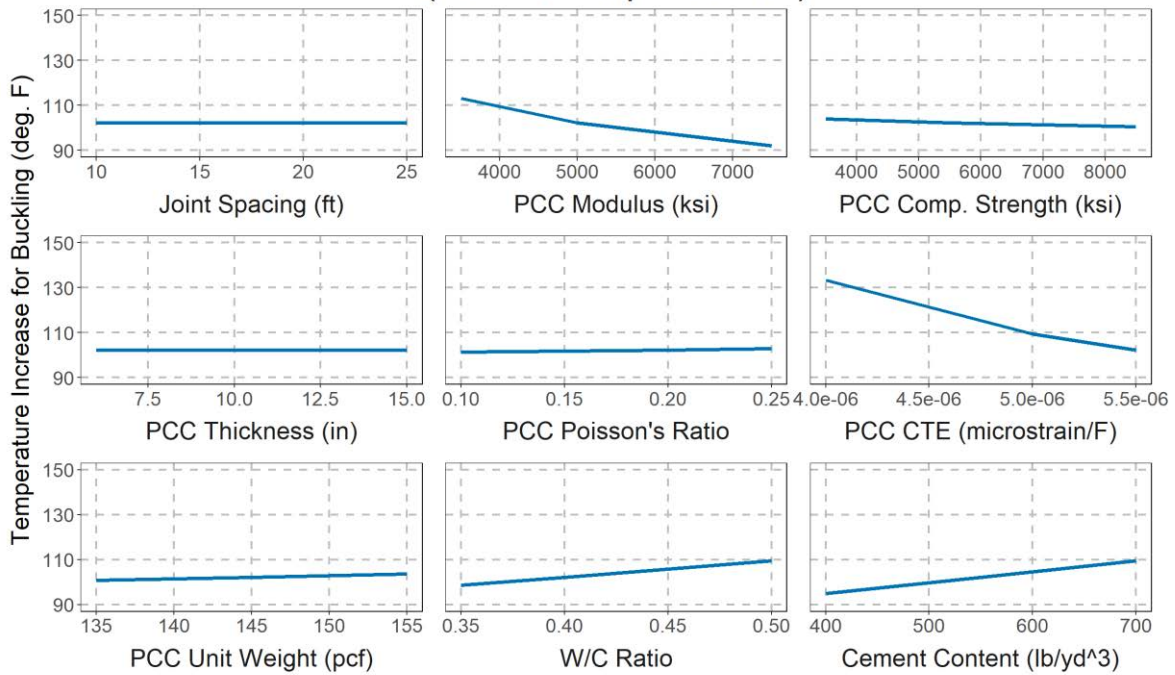
Figure 39. Sensitivity of Buckling Temperature to Various Inputs (GB).

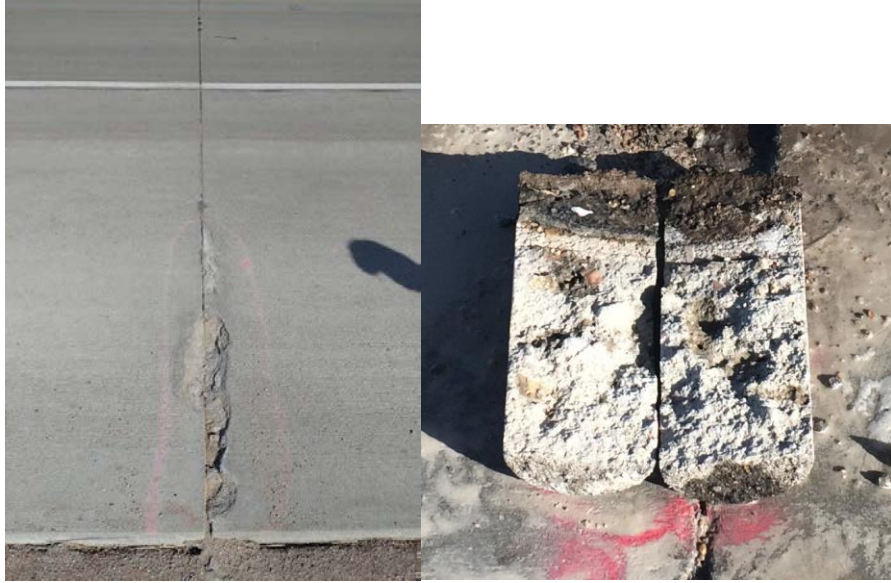
Figure 43. Spalling along the shoulder joint where incompressibles infiltrated after only 1.5-years of service on I-80 in Nebraska (left). Core taken in the spall area (right).

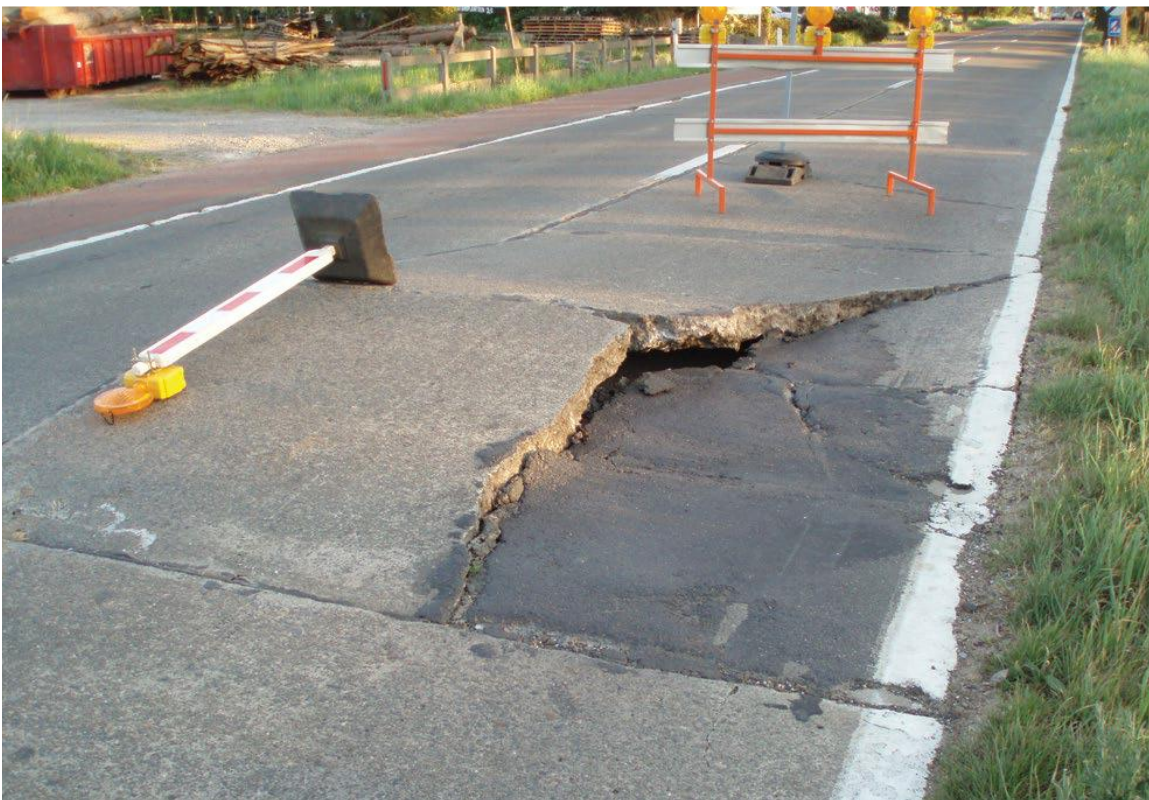
Figure 45. Buckling caused by HMA patching (Rens 2018).

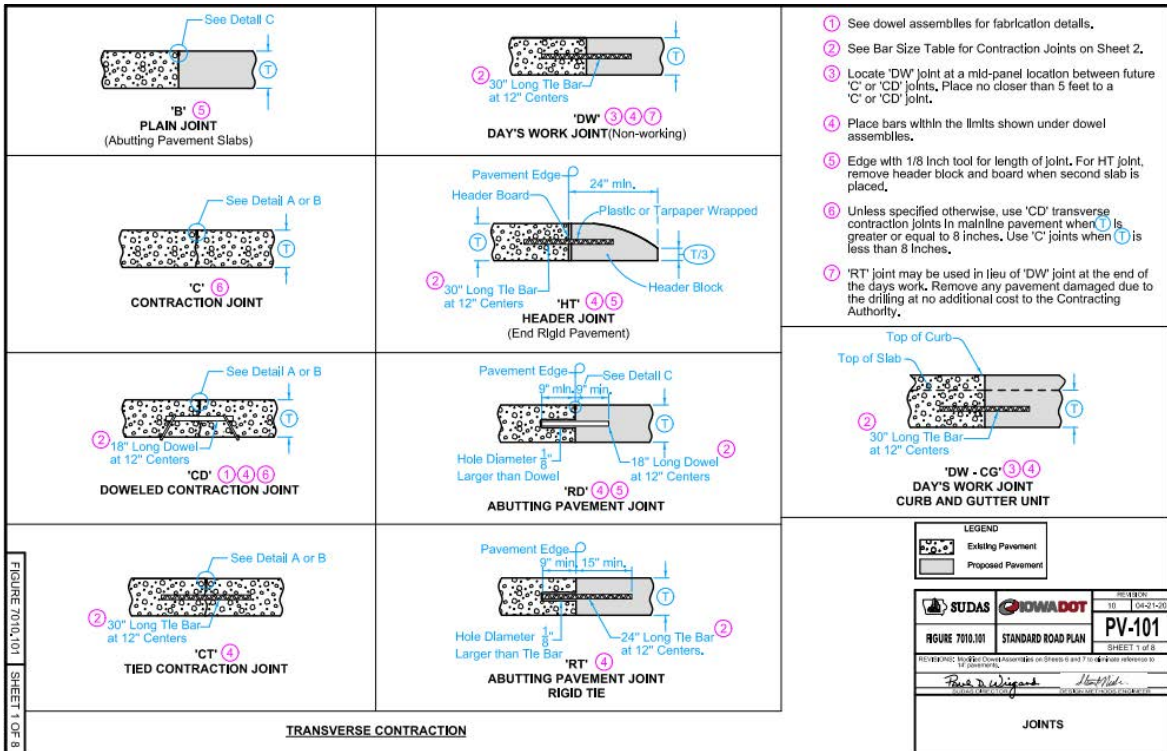
Figure 47. Transverse contraction joint design layout (Iowa DOT 2020).

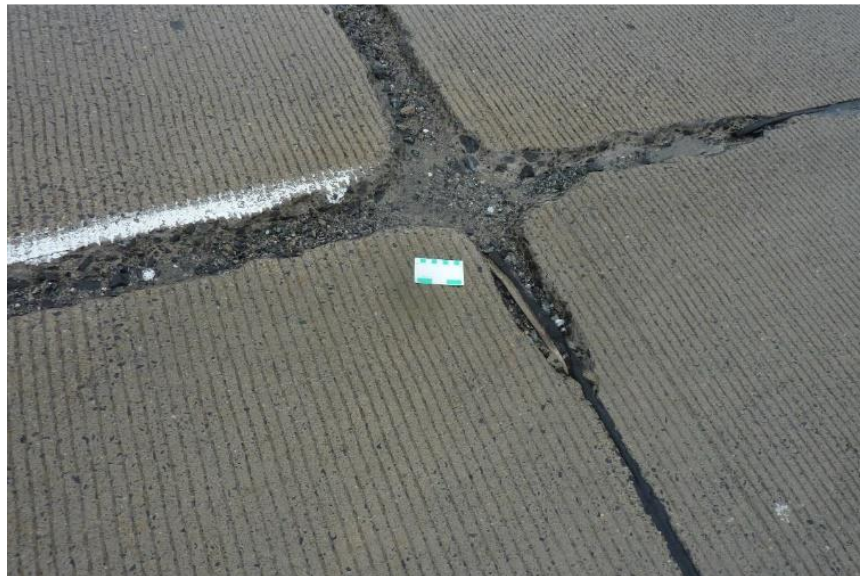
Figure 65. Deteriorated Joints on Highway 417 (Chan et al. 2020).
