# Arizona US 93 NB Silicone Joint Sealant Evaluation (040160)

IGGA/ACPA  
Larry Scofield, P.E.  
6/2/2022

## **Introduction**

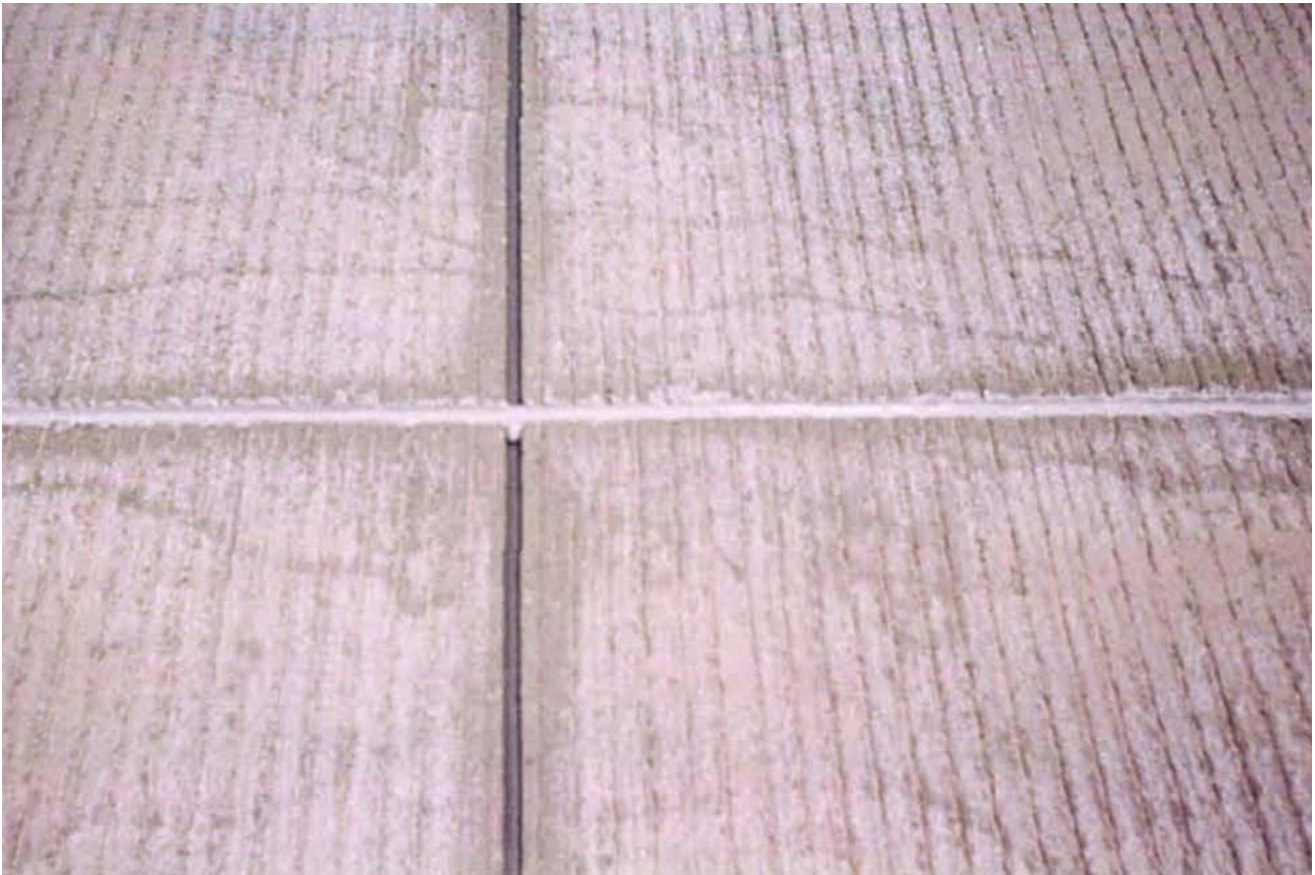
**Figure 3-8 Backer Rod and Sealant Installation**

A 1/2" backer rod (Hot Rod XL made in Canada, lot #C2934), was placed in all longitudinal and transverse joints (Appendix A). A Crafcro non-slump grey silicone sealant was then placed on top of the backer rod (Appendix A). It was fairly windy during placement and some fines were blown onto the sealant prior to its skinning over, but not a significant amount to cause problems. Arizona DOT personnel measured all reservoir cuts before and after backer rod installation and found the depths to be all within specifications.
