TRANSVERSE JOINT DISTRESS AND MID-SLAB CRACKING DISTRESS IN PCC PAVEMENTS A PETROGRAPHER'S PERSPECTIVE

David Lankard

Dr. David Lankard, President and Petrographer, Lankard Materials Laboratory, Inc., 400 Frank Road, Columbus, OH 43207. lm12@netwalk.com. Proceedings of the 10th International Conference on Concrete Pavements, July 8-12, 2012, Quebec City, Quebec, Canada. www.concretepavements.org.

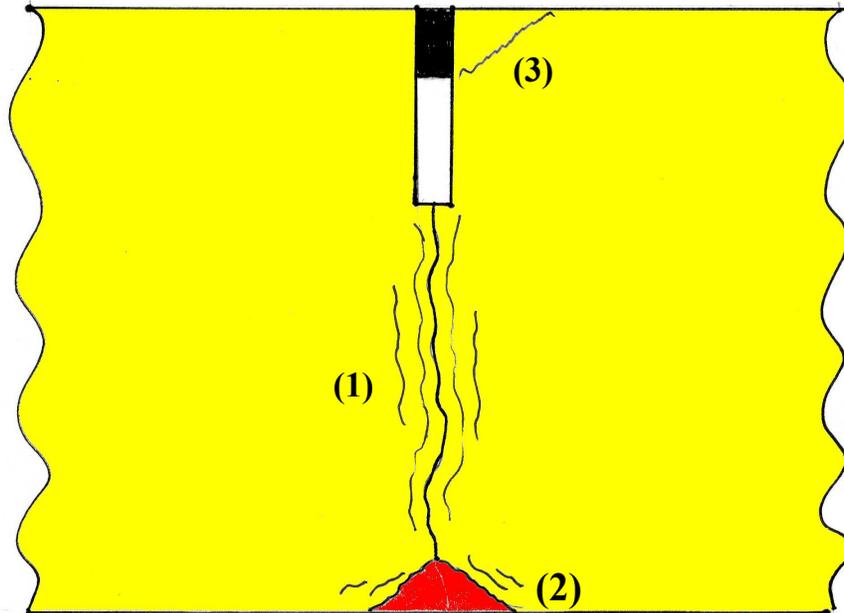
In the Type 1 cracking pattern shown in Figure 1, the sub-surface cracks (singles and multiples) are roughly parallel to each other and to the plane of the original joint crack or to the plane of the mid-slab crack. These cracks are present in the cores just below the bottom of the joint saw-cut in the joint cores, and 2.5 to 7.5 cm (1 to 3 in.) below the wearing surface in the mid-slab crack cores. This cracking is referred to in future

text as “Type 1 cracking.” Type 2 cracking occurs in the concrete at the bottom of the slab directly beneath the joint crack or the mid-slab crack.

When viewed in two dimensions as in Figure 1, the crack pattern has the shape of a bisected cone, with the apex of the cone lying under the original joint or mid-slab crack. Frequently, this results in a spall (red area).

Figure 1. Schematic of the type of cracking exhibited by the joint and mid-slab crack cores examined in the present study (not to scale).

With time, the presence and progression of Types 1 and 2 cracking distress can lead to a complete break-up of the concrete within the confines of the cracks (becoming a spall). When this occurs, there is a loss of sub-surface support, and repeated traffic loadings place the concrete in the region of the joint and mid-slab crack in flexure, rather than compression (Site 3 in Figure 1). At this point the cracking and spalling will be manifested at the wearing surface along the joint or the mid-slab crack line. The Type 3 form of distress is made worse if upward curling has occurred in the pavement slabs.
