Maintenance and Longevity of Longitudinal Joints

LARRY GALEHOUSE AND LARRY SCOFIELD

Background on Longitudinal Joint Maintenance

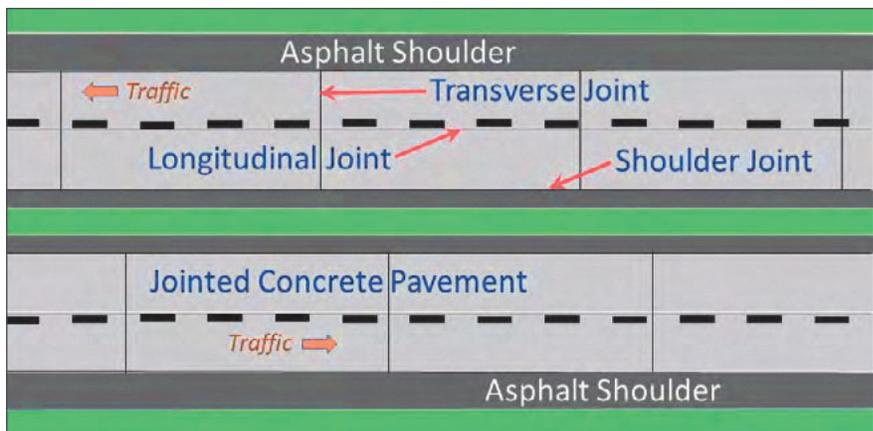
FIGURE 1 Typical pavement joint configuration.

Many highway agencies have discovered that significant safety issues often occur when longitudinal pavement joints deteriorate. This deterioration can appear in both asphalt and concrete pavements and is typically visible at longitudinal lane joints and shoulder joints (Figure 1).

Joint deterioration in asphalt pavements is a consequence of improper bonding of a new mix to the adjacent pavement surface or the result of lower densities at the joint due to poor compaction during paving. The lower density results in higher air-void levels at the joint, leaving it permeable and susceptible to the intrusion of water that accelerates deterioration. In time,

the joint tends to ravel under traffic and material is then lost.

Generally, infiltration of surface water into the pavement structure at traverse and longitudinal joints is the cause of concrete pavement deterioration. Filling joints with an engineered sealant will eliminate the intrusion of water and reduce the potential of future pavement degradation.

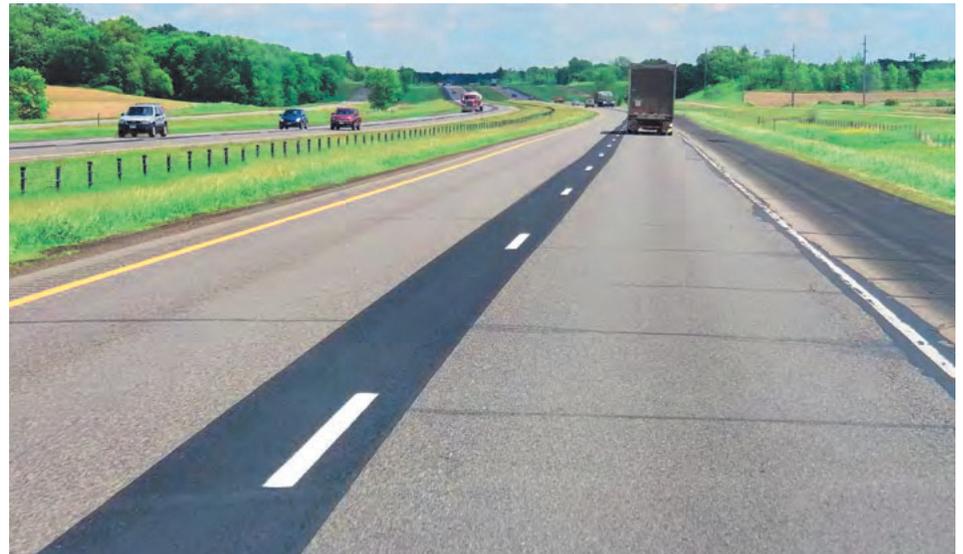
Interstate 94 near St. Cloud is one of several Minnesota roadways benefiting from micro surfacing as a practical—and affordable—solution for deteriorating longitudinal joints.
